SERVICE BULLETIN

APPLICABILITY: 2017-18MY Impreza
 2018MY Crosstrek
 2018MY Legacy and Outback
 2018MY BRZ

NUMBER: 15-211-17R

SUBJECT: Reprogramming File Availability for Additional Optimization of Harman Gen 3 Audio and Navigation Head Units

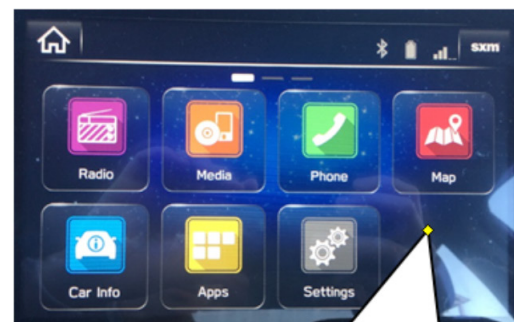
- Corrects for condition where only the star field background is displayed (without icons) after the HOME button is pressed.

Background shown, but no icons

Normal HOME screen with icons

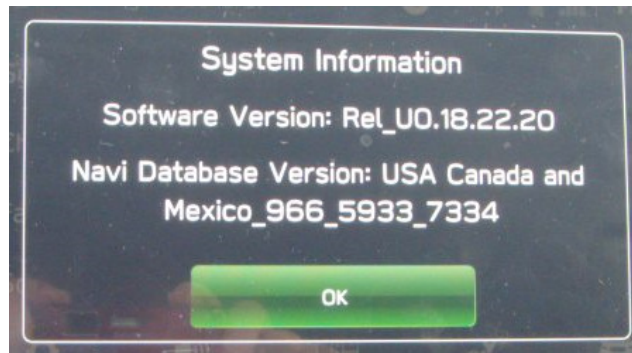
- Confirm the current Software Version ID. If the Current Version is **Rel_U0.18.22.20 STOP** as this latest update has already been installed.
