## Brake Disc and Brake Pad Service and Reference Information

This Service Information bulletin supersedes SI 34 06 13 **dated March 2015**.

Determining when to service brake components

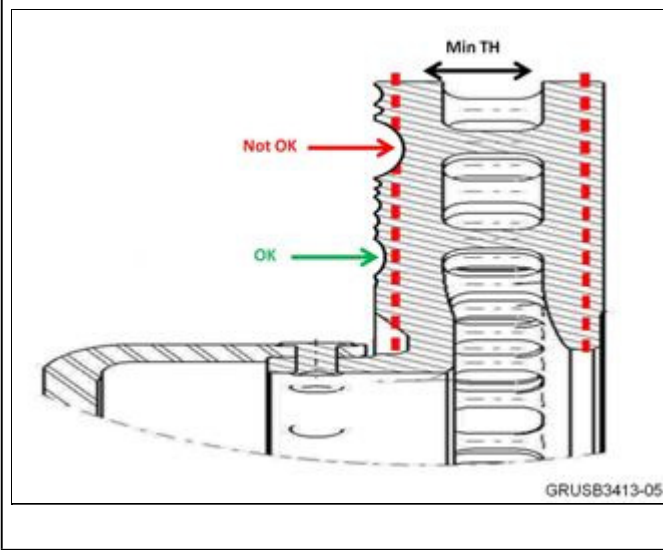
Grooves in the brake discs can be seen through these wheel openings and are purely visual; this in no way affects braking performance. No repair attempt is needed.

However, the groove depth must be evaluated to determine if replacement is necessary. If the groove's or grooves' depth goes beyond the minimum thickness, disc replacement is necessary.

- Always refer to the Repair Manual for model-specific information.
- Always replace discs in pairs (per axle).

- Install new brake pads when replacing discs.

Attach a hang tag to the inside rearview mirror after completion of repair work.
