Service Action: Repair Corrosion Protection Engine Compartment

F30 (3 Series Sedan)

F30H (ActiveHybrid 3)

Produced from June 2012 to January 2013

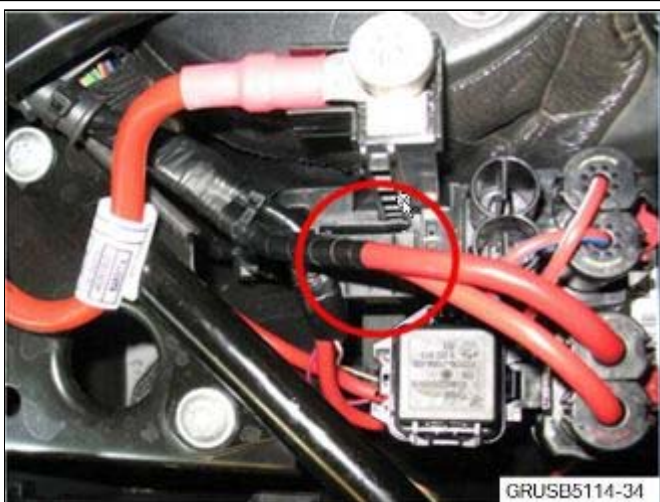
- This picture shows the installation location of the cover to be replaced, below the battery positive cable.

3. Replace the cover on the battery positive terminal.
