Technical Information Bulletin

34-070

34 – Wiring and Lighting

DAVIE4 Unable to Update VECU Software

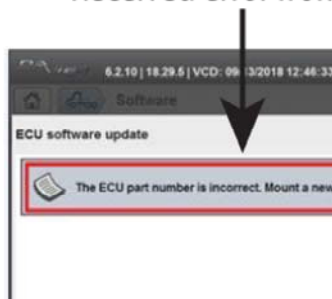
Received error from

The DAVIE4 service tool is unable to support software updates on VECUs with the PACCAR no: Q21-1126-500-500 when the last two digits of the ECU Hardware number are replaced with "X X" (see procedure section below). The DAVIE tool will demonstrate an error and will not allow programming DAVIE4 Service Tester 18.29.5

DAVIE4 cannot perform the verification check and will not allow any further programming due to incorrect programming.

DAVIE4 field release 18.41 will be available in week 43 (10/19/2018) to fix this issue. Before Week 43 (10/19/2018), contact the Vehicle Support Center for an interim patch that will correct the part numbers in the VECU.

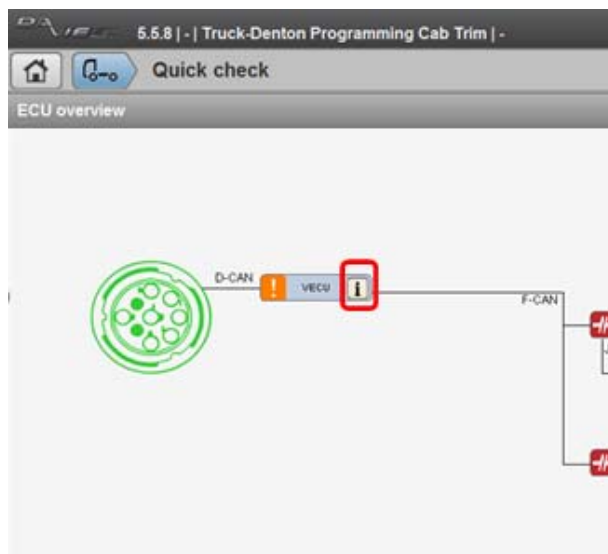
- The patch is required when:
 - There is no PACCAR hardware number shown.

- The ECU hardware number is missing the last 2 digits. The last 2 digits will display "X X".

- Click on the VECU iPane (VECU Information).
