ATU (Audi Technical Update)

Summer 2018

4.0 TFSI – Camshaft Diagnosis

A3 e-tron refuelling issue

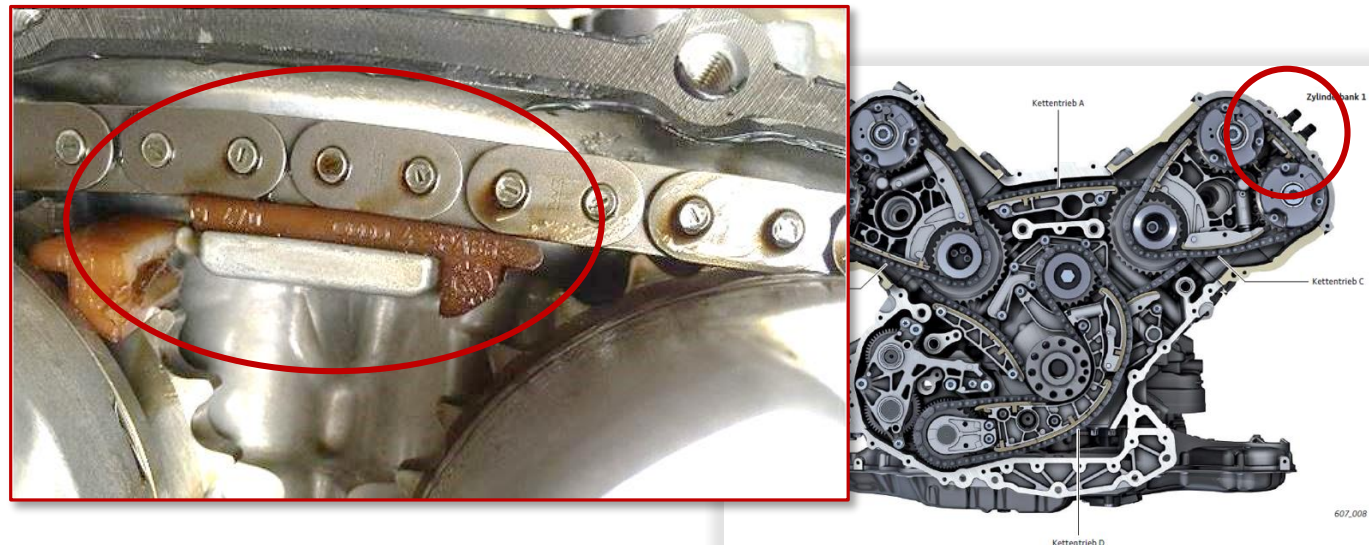
- › Damage:
 - › Broken filter element on camshaft control valve.

Recommended repair procedure:

- › Check control valve for damage to filter element:
 - › Filter element OK → Recommendation: Clean oil passage between control valve and camshaft control valve with compressed air and replace camshaft adjuster on affected cylinder bank (as shown in DTC).
 - › Filter element not OK → Replace the control valve.
 - › **Important:** Identify optimized camshaft adjuster based on the production code on camshaft adjuster!
 - › **Important:** The chain drive glide rail part number 079109470A should be checked when replacing the camshaft adjuster. Replace the glide rail if it is not part number 079109470A.

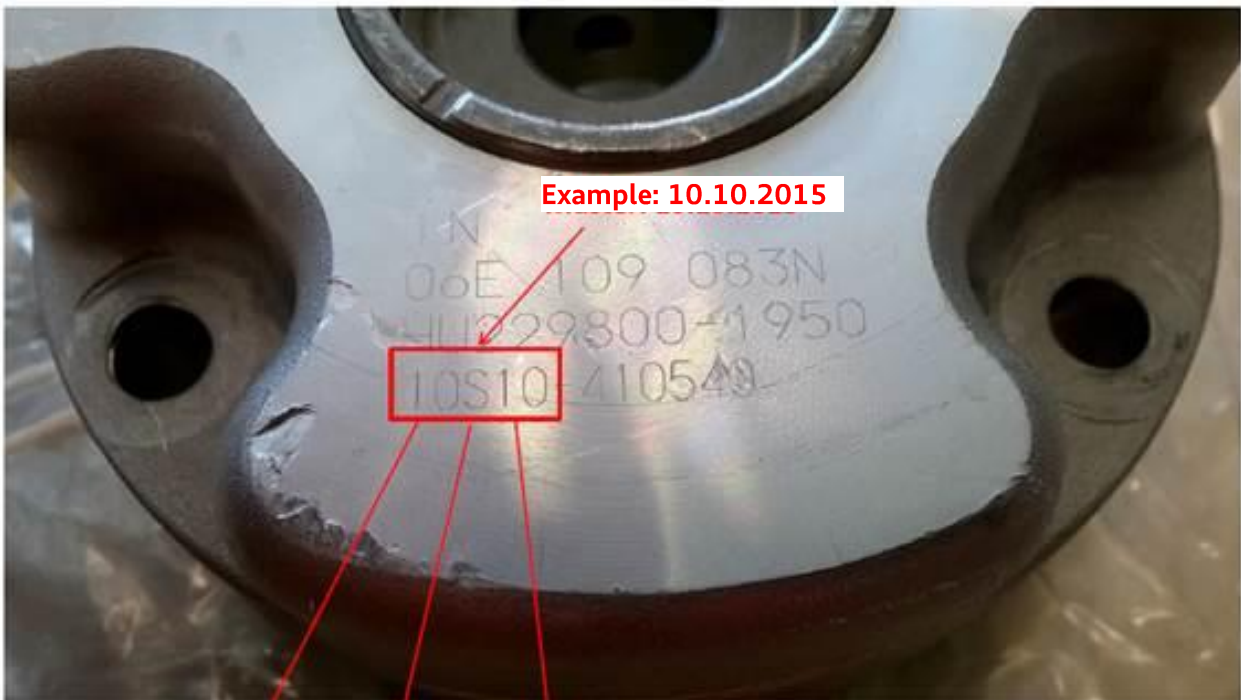
Example: 10.10.2015

- › Identify optimized camshaft adjuster based on the production date of camshaft adjuster.
