Seat cushion fore/aft adjuster seat cushion cover becomes detached

Topic number	LI91.18-P-049463
Version	3
Function group	91.18 Seat covers
Date	07-31-2018
Validity	BR204 and 207 with SA code 409 (Multicontour seat) and BR212 with SA code 409/432 (Multicontour seat/active multicontour seat) BR 205 and 213 with SA code P65 (Seat cushion fore/aft adjustment) and with 275 (Electrically adjustable driver seat with memory function) or 241 (Electrically adjustable front seats) or 242 (Electrically adjustable front passenger seat with memory function)
Reason for change	BR213 added
Reason for block

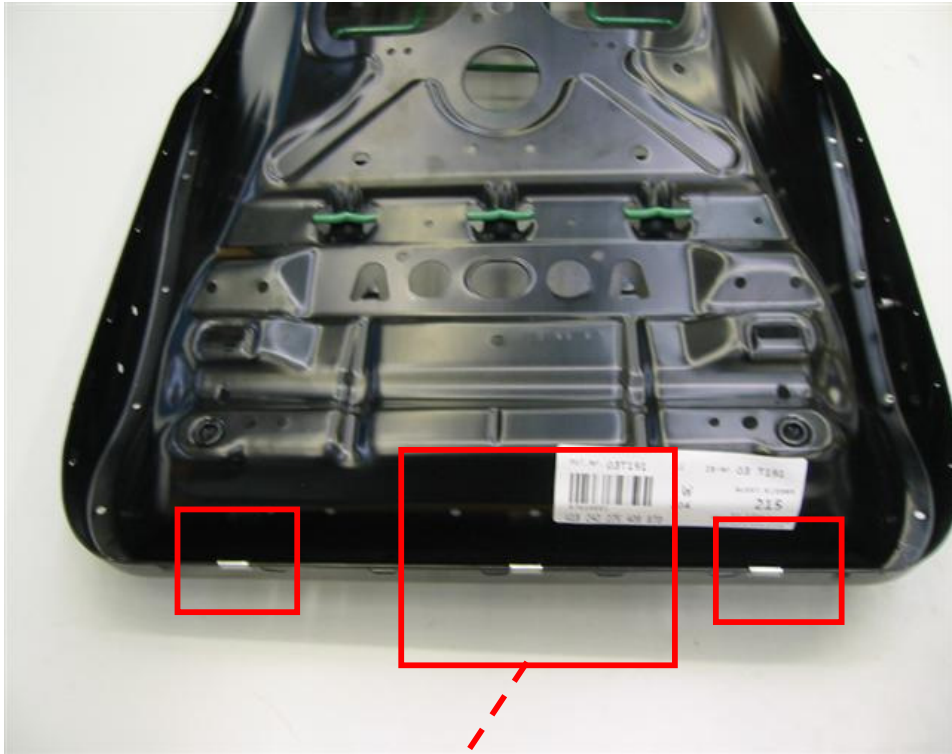
P1040937.JPG:

- Model series 204 and 212: Insufficient holding ability of the fastening strip
- Model series 207: Matting incorrectly positioned. (See picture P1040937)
- Model series 205 and 213: Insufficient holding ability of the fastening strip

Attachments	
File	Description
P1040937.JPG	Matting trapped in profile

- Model series 204 and 212:
 - Remove cushion as per AR91.10-P-3310CW
 - Fit clips as described in the attachment
 - Reattach cover accurately
