Technical product information

Topic	W12 - Oil leak from engine
Market area	Bentley: worldwide (2WBE),Hongkong-Macau (5HK)
Brand	Bentley
Transaction No.	2053350/1
Level	EH
Status	Approval
Release date

New Continental GT

Bentayga

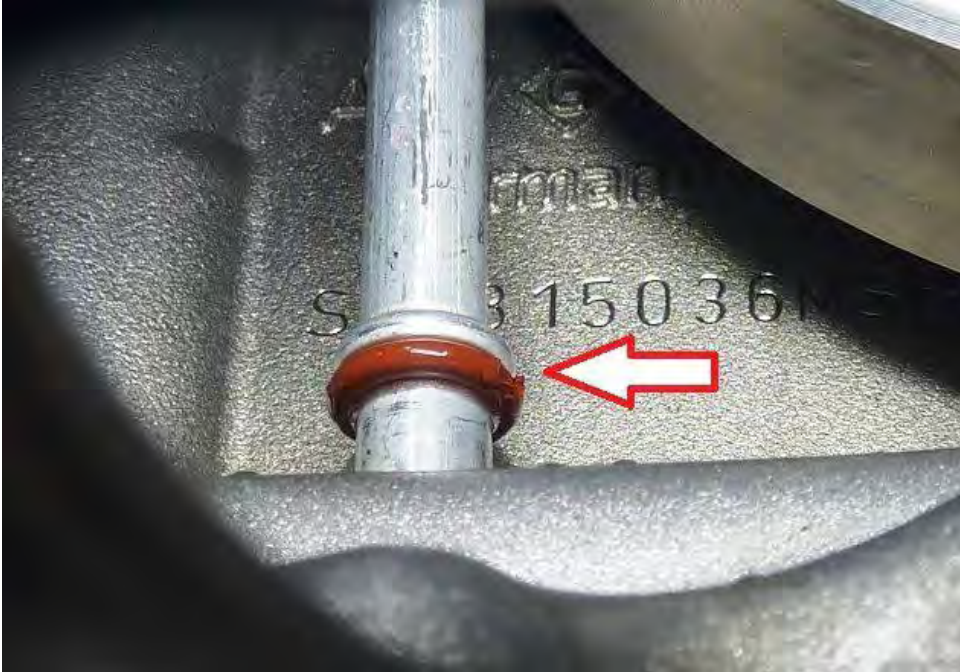
The breather return line and the oil dipstick tube O-rings can split causing an external oil leak.

This can be misdiagnosed as the engine sump leaking.

If an engine oil leak is found from the area shown in Figure 1, check the O-rings of both the breather return line and the dipstick tube for leakage. The oil can run down the engine and settle on the sump leading to misdiagnosis, Figure 1.
