**PRODUCT CAMPAIGN BULLETIN**

**APPLICABILITY:** 2018 Model Year Legacy and Outback Vehicles      **NUMBER:** **WTW-82R**  
**SUBJECT:** Combination Meter Reprogramming      **NHTSA ID:** 18V-773  
**DATE:** 12/11/18  
**REVISED:** 02/21/19

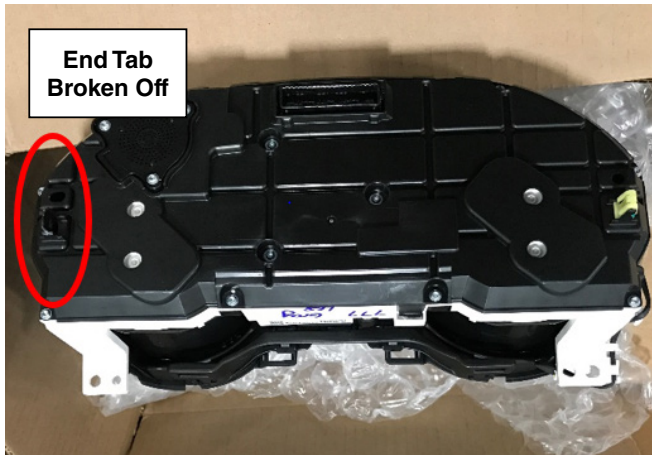
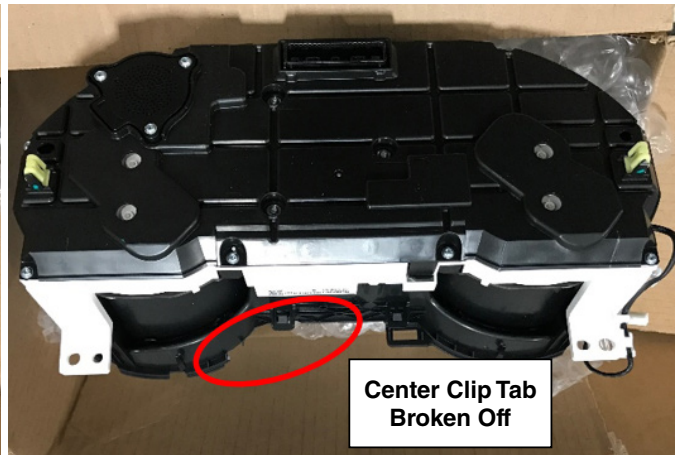
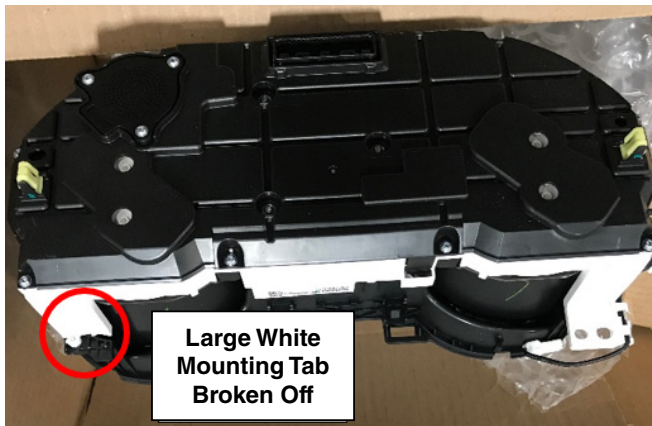
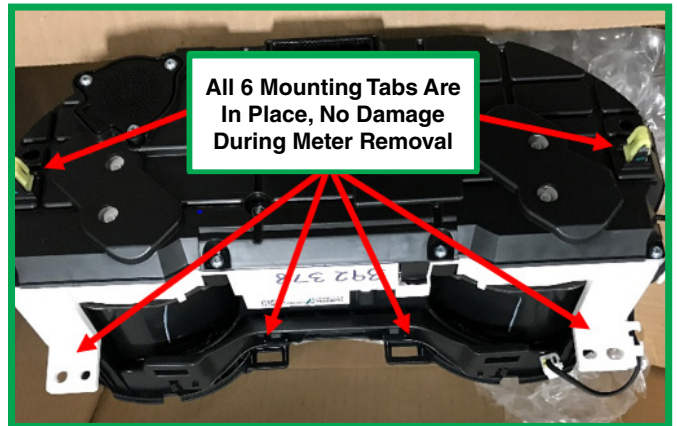
**REMINDER:** Before proceeding to **Step 6** below, it cannot be stressed enough for Technicians to **TAKE THEIR TIME** when removing and reinstalling the combination meter. The photos below illustrate what can happen to the meter assembly when not performing these steps **CAREFULLY**. These 3 examples all show damage caused by outside influence which is not a matter for warranty.
