Technical Service Bulletin

15 Oil leak from cylinder head - 2.9 and 3.0TFSI only

15 19 33 2053278/2 February 5, 2019. Supersedes Technical Service Bulletin Group 15 number 18-32 dated December 17, 2018 for reasons listed below.

Model(s)	Year	VIN Range	Vehicle-Specific Equipment
All	2018 - 2019	All	3.0 TFSI
All	2019	All	2.9TFSI

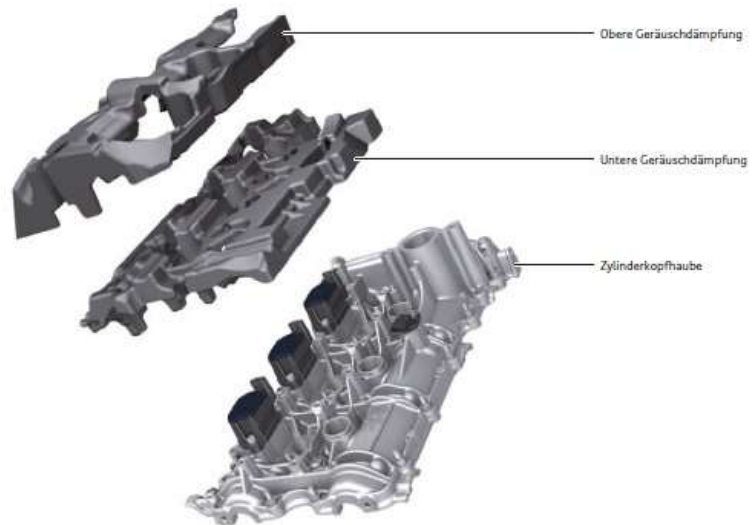
Figure 1. Removing the upper noise insulation.

1. Remove the engine compartment cover and the heat shield below it.
2. Remove the upper noise insulation of the affected cylinder bank (Figure 1).

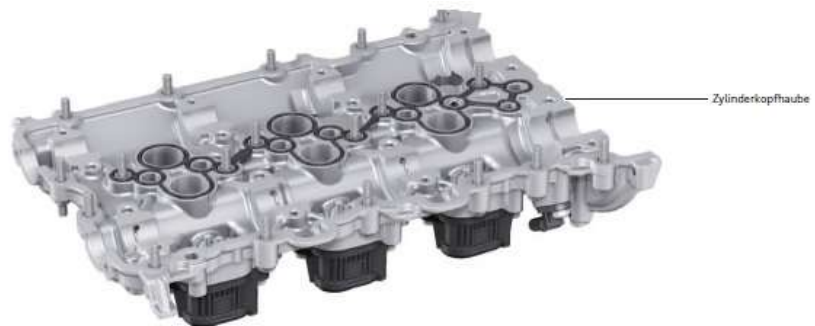
Figure 4. Remove the cylinder head cover.

6. Remove the cylinder head cover and the seal (Figure 4).
