Message in instrument cluster in yellow "Battery Symbol – Start Engine. See Owner's Manual"

Topic number	LI54.10-P-065969
Version	4
Function group	54.10 Battery, power supply, voltage converter
Date	10-27-2017
Validity	BR205/253 up to production date 12/2016 Only affects vehicles with Hyundai Mobis battery sensor.
Reason for change	Details of the situation added to avoid the unjustified replacement of Bosch battery sensors that are not affected by this fault profile.
Reason for block

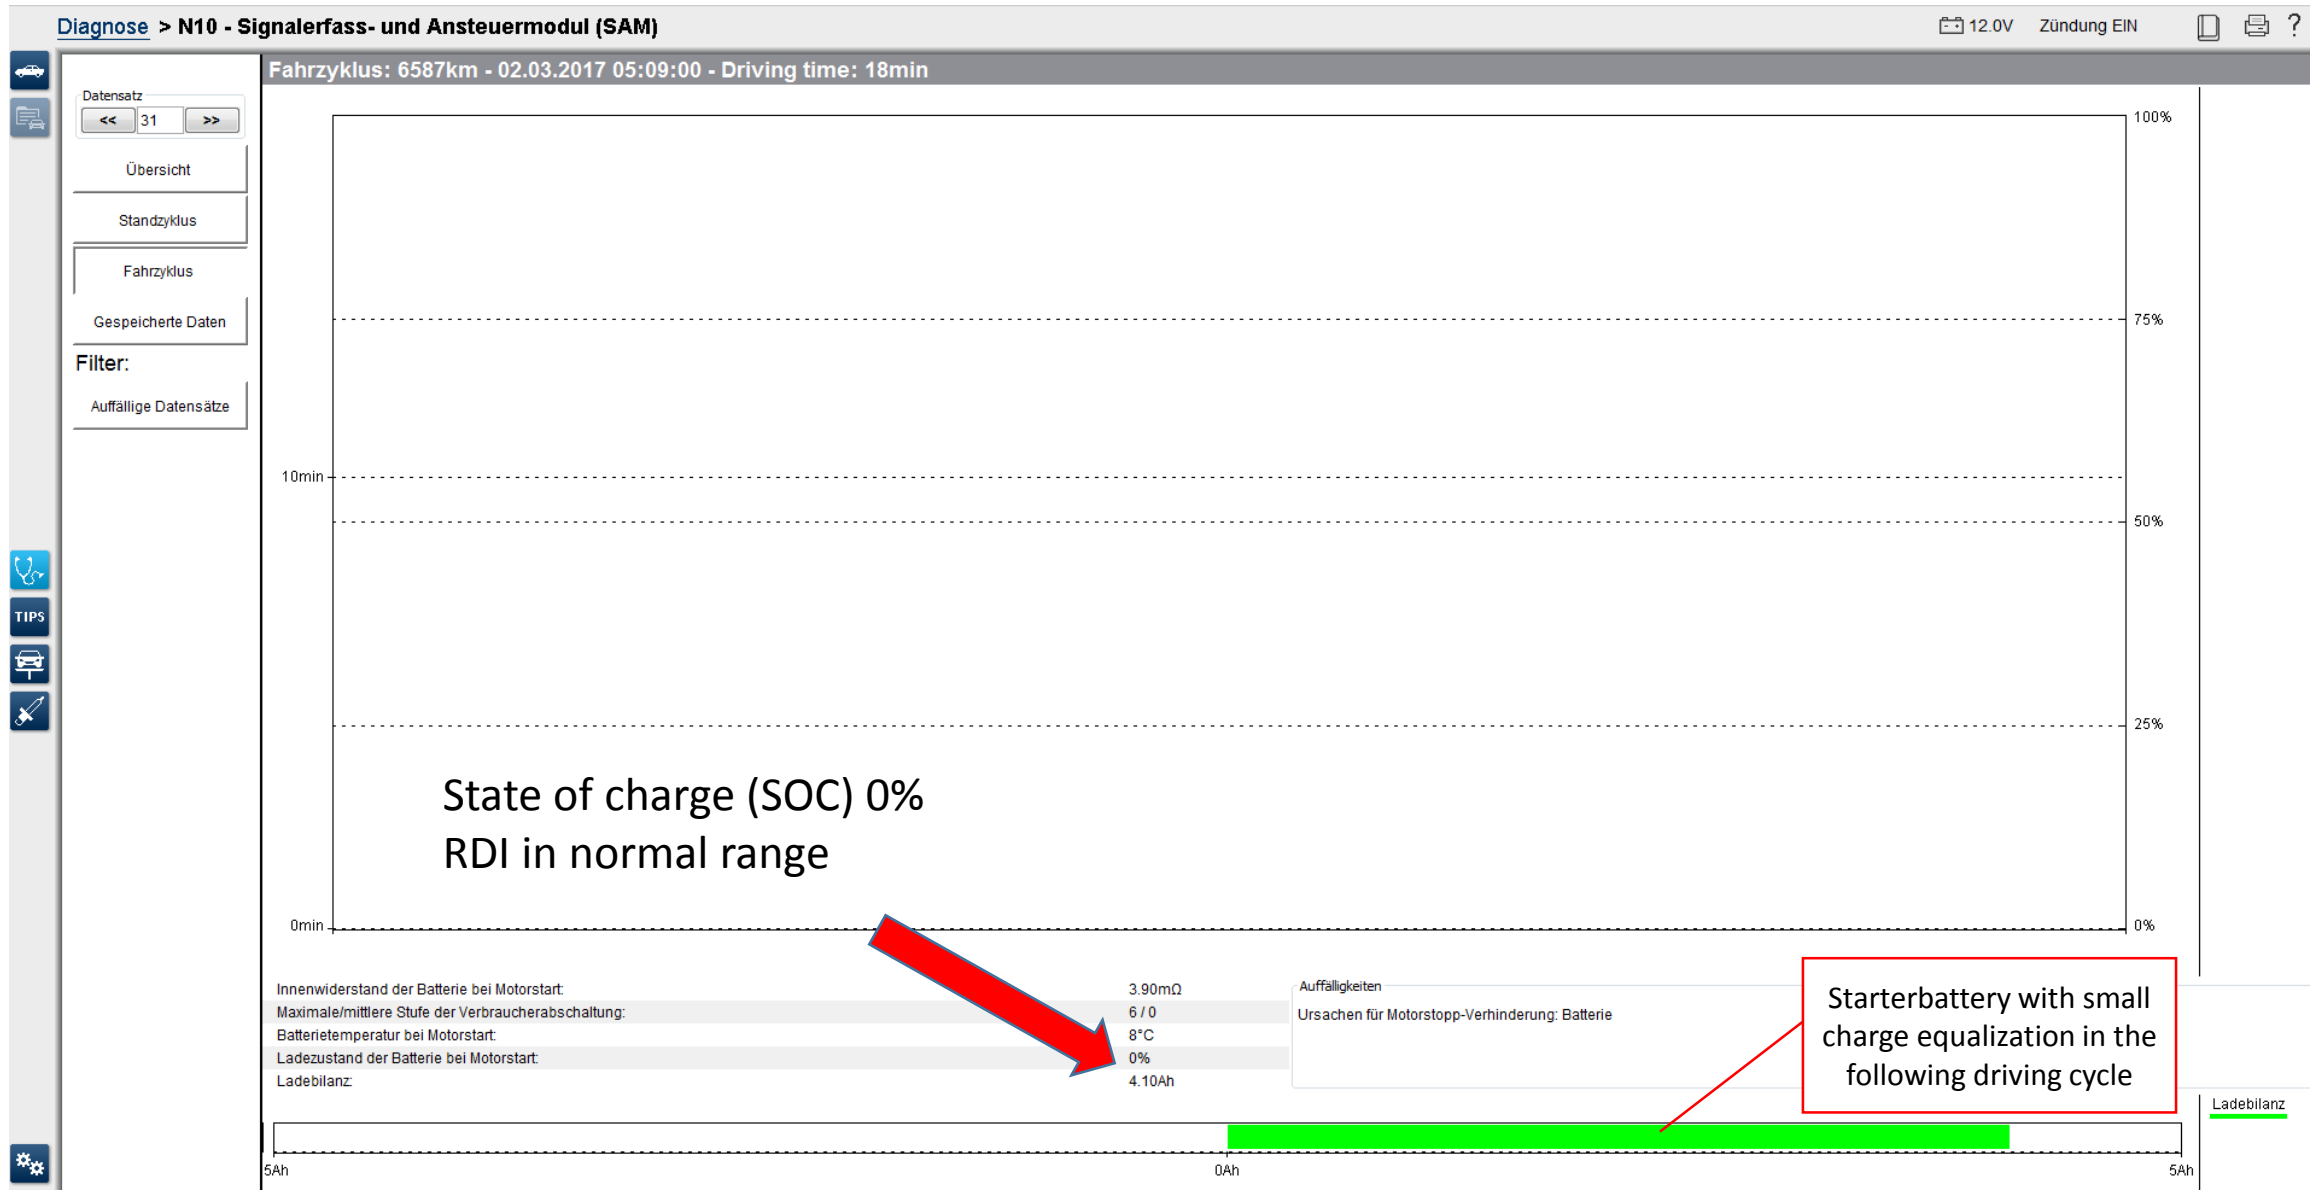
Measurement Driving cycle

Error in the calculation of the charge balance and the state of charge of the battery that causes an unjustified message in the Instrument Cluster display as described in the Complaint section above.

6) Reference the attachment ("Error in the calculation of the charge balance") which is an example of the On-Board electrical System data when the IBS Battery Sensor needs replacement.

If the vehicle meets the conditions described above proceed with the replacement of the B95 battery sensor [see Parts].
