Service Bulletin

Bulletin No.: 19-NA-055

Subject: Accessory Front Floor Liner Warped, Bent Inward

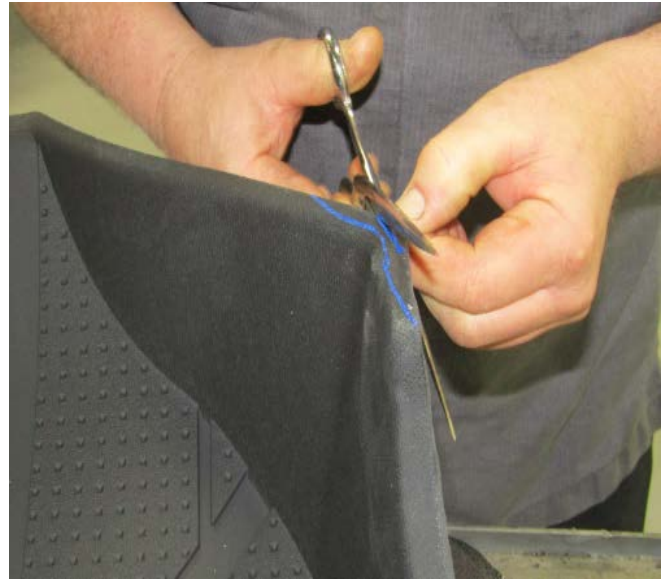
5280130

- If the outboard corner, remains warped or has taken a set, the trimming repair will not improve the condition and it would be necessary to replace the floor liner.
