**** TECHNICAL INFORMATION NOTICE ****

DATE: April 25, 2018
TO: Mitsubishi Motors US & Puerto Rico Dealer Service and Parts Managers
RE: CPX-930 Software Update
TIN NO. TIN-19-00-002

AFFECTED VEHICLES: All models and model years

CPX-930 Update with USB

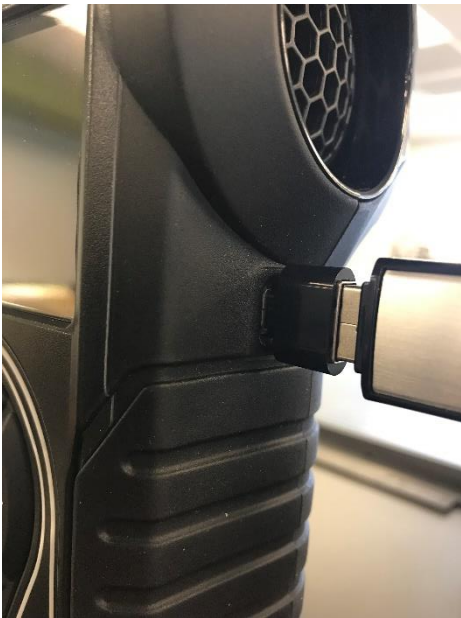
1. Power on the CPX-930 by pressing the power button then place the CPX in docking station.
2. During update process, do not remove the CPX from docking station.
3. Plug in the USB drive using the Micro USB adapter.

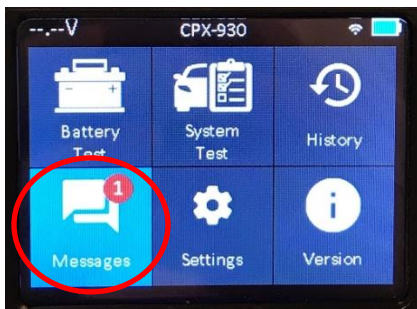
4. Within 30 seconds, a red alert will be displayed on the “Messages” icon indicating the update has been recognized.

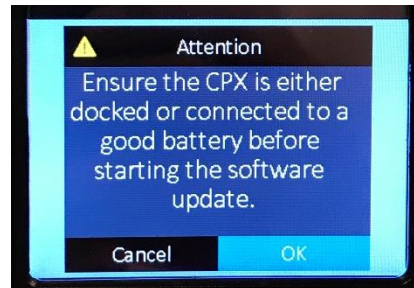
5. Keeping the CPX firmly in the docking station, use the keypad to select “Messages” and begin the update process.
6. A warning message will appear reminding you to leave the CPX docked or connected to a good battery (if no docking station available). Select OK to continue.

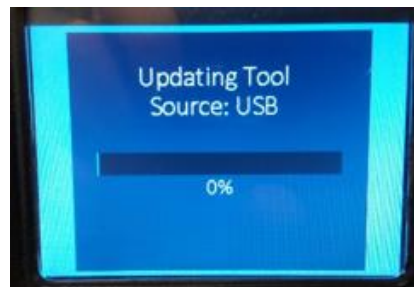
7. The update will begin to download, and a progress bar will appear.
Note: Progress could remain at 0% for up to 3 minutes before displaying the percentage of the update file being downloaded.

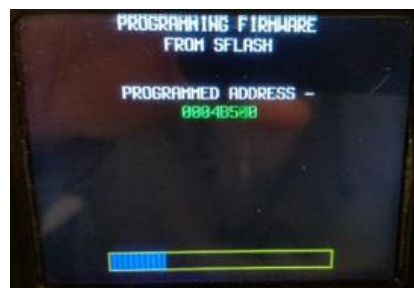
8. After approximately 30 minutes, the download will complete, and the update will begin.

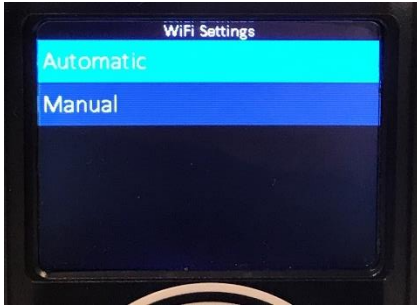
9. Once the update completes the tool will reset and bring the user to the first screen in the setup process. Unplug the USB and Micro USB adapter. Save the Micro USB adapter for future updates.

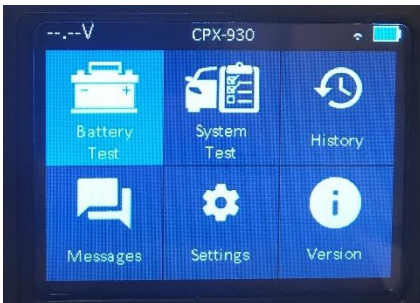
10. The CPX-930 will require the user to go through the Initial Setup process. Once the Initial Setup is complete, the CPX is ready for use.
