NUMBER: 08-033-15 REV. B

Flash: RE2 RE3 RE4 RE6 RE7 RB4 RB5 RB6 RB4 Radio Enhancements

This bulletin involves updating the radio control head software and navigation if equipped.

2013-2014	(LD)	Dodge Charger
2013-2014	(LX)	Chrysler 300
2013-2015	(JC)	Dodge Journey

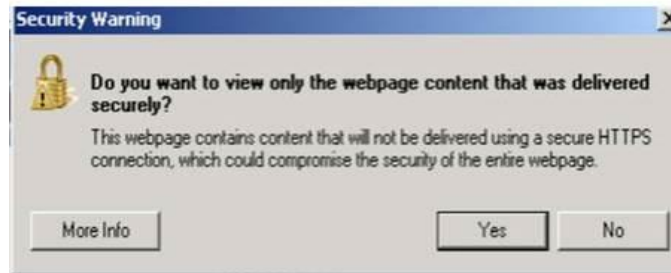
Fig. 2 Pop-up Security Message

7. If a security message appears “Do you want to view only the webpage content that was delivered securely?” See (Fig. 2). Press **No** to continue.

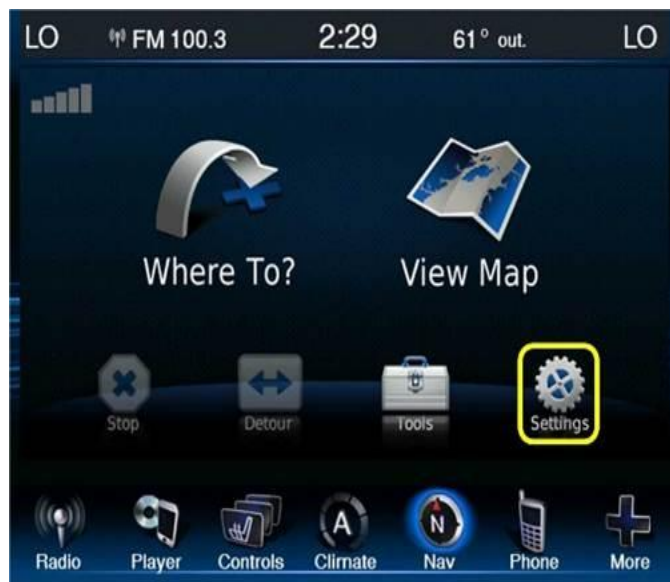
Fig. 3 Settings Icon

- 13. When the update is completed, the screen will read “Reflash Successful”. Touch the screen and the radio will reboot.
- 14. The screen will now show the current and new software levels. Verify if the new and current software levels are now the same and press no on the screen.
- 15. Remove the USB flash drive from the USB port and proceed to [Step #16](#).
- 16. Does this vehicle have one of the following non-navigation radios, RE2, RE3, RE6 or RE7?
 - a. Yes >>> Only the radio control head needs to be updated, this bulletin is now complete.
 - b. No >>> The Garmin navigation system update needs to be performed, proceed to [Step #17](#).
- 17. From the navigation main menu screen, press the Settings screen button. See ([Fig. 3](#)).

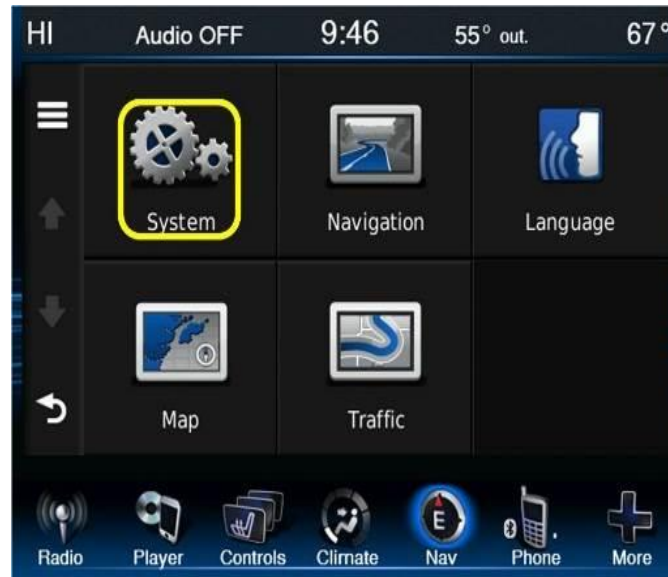
Fig. 4 System Icon

18. Press the System Icon. See (Fig. 4).

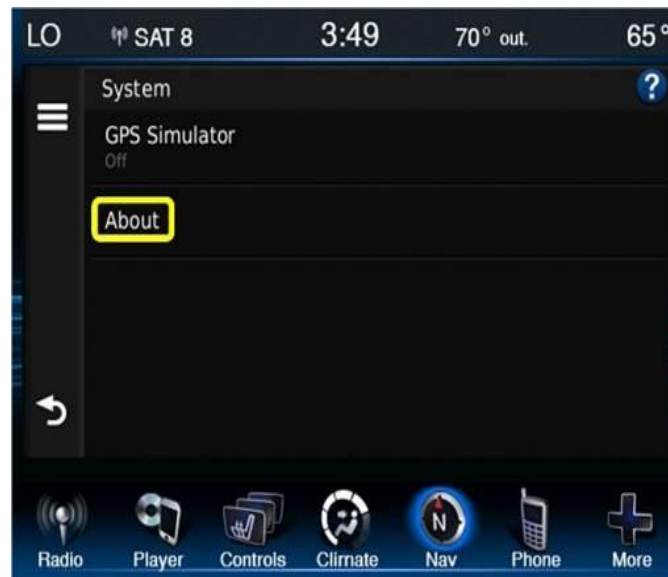
Fig. 5 About Icon

19. Press the About screen icon, See (Fig. 5), and record the software version.

20. Is the software version lower than 6.22.
 - a. Yes >>> Proceed to [Step #21](#) and perform the update.
 - b. No >>> The Garmin Navigation system is already up to date. The bulletin is now complete.
21. Insert the correct USB flash drive containing the Garmin Navigation update into the USB port.

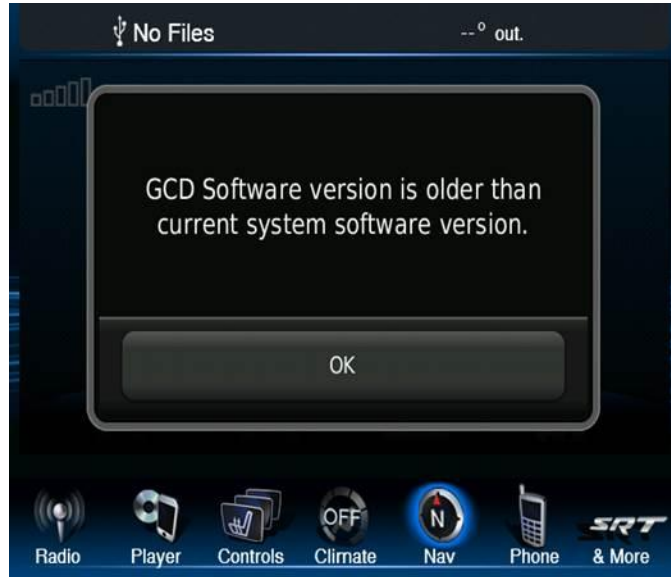
Fig. 6 Garmin Software Already Updated

22. The radio screen will now display one of two pop up screen see (Fig. 6) or (Fig. 7).

23. Which screen does the radio currently display?
 - a. (Fig. 6) >>>The radio has the latest Garmin software installed. Press OK and proceed to [Step #27](#).
 - b. (Fig. 7) >>>Press Yes to continue and proceed with the Garmin software update, proceed to [Step #24](#).
24. The first step in the update is "system recover". There will be a pop up that indicates this step along with a progress bar. This will only take a few minutes.

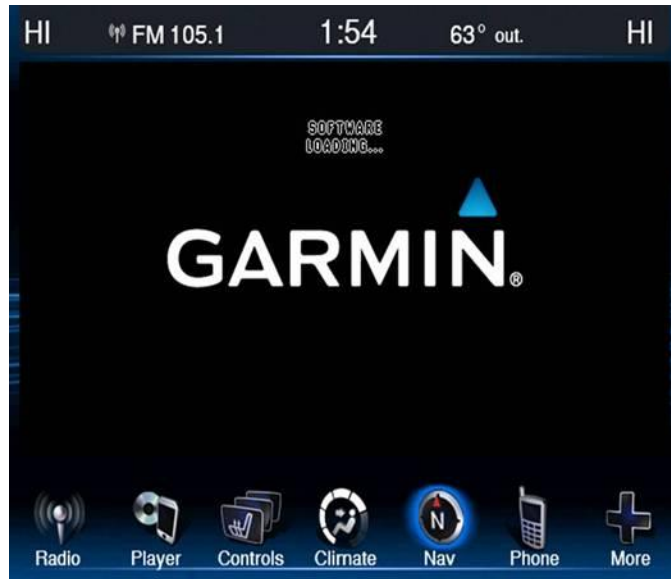
Fig. 8 Garmin Software Loading

25. This next screen will be displayed when the update is being down loaded, see (Fig. 8).

CAUTION: Do not interrupt the software update process once it has begun. It may cause permanent damage to the radio which will require replacement.

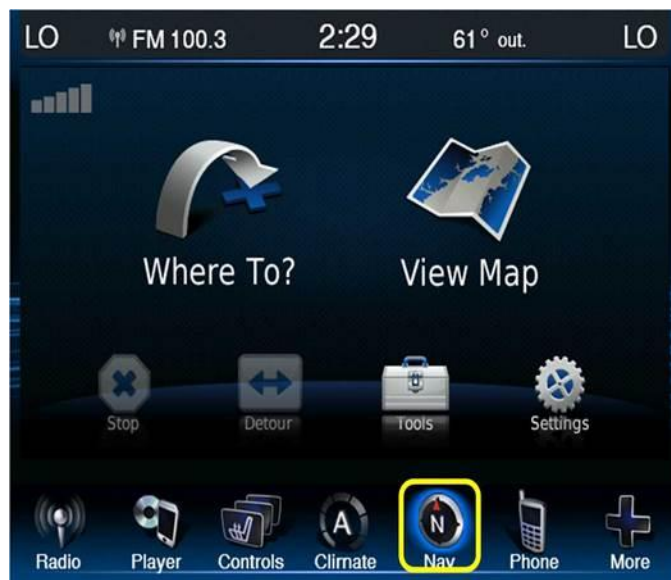
Fig. 9 Update Complete

26. When the software has completed down loading, the screen will change to the Garmin main screen, see (Fig. 9).

27. Remove the USB flash drive and cycle the key. The bulletin is now complete.
