SI B13 02 19
Fuel Systems

SERVICE ACTION: CHECK THE TANK VENT VALVE LINE

G01 (X3 xDrive30i, X3 M40i)			
-----------------------------	--	--	--

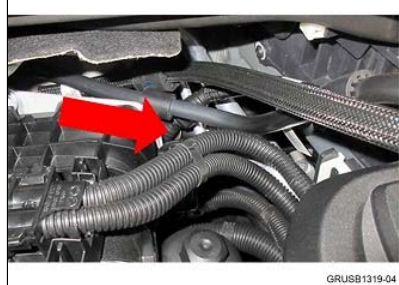
Visually inspect engine wiring harness and tank vent valve line.

If the clearance between the tank vent valve and engine harness is incorrect and the tank vent valve line is damaged, it must be replaced.
