**SERVICE PROGRAM BULLETIN**

**APPLICABILITY:** 2017 MY Legacy  
2017 MY Outback

**NUMBER:** WUD-89

**SUBJECT:** Combination Meter Reprogramming Service Program

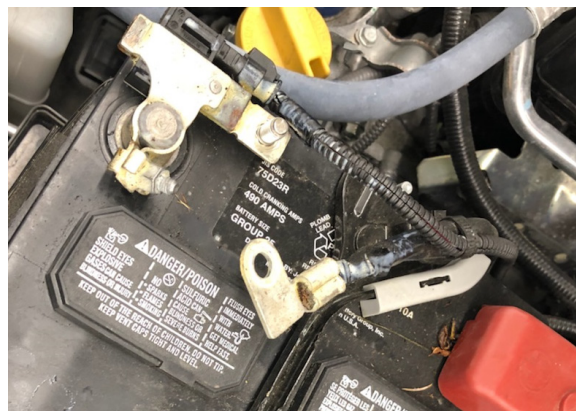
**Step 3:** While holding / supporting the battery sensor with 1 hand (to keep it from turning), use the 12mm socket to remove the negative battery cable. **DO NOT** remove the sensor from the battery post.

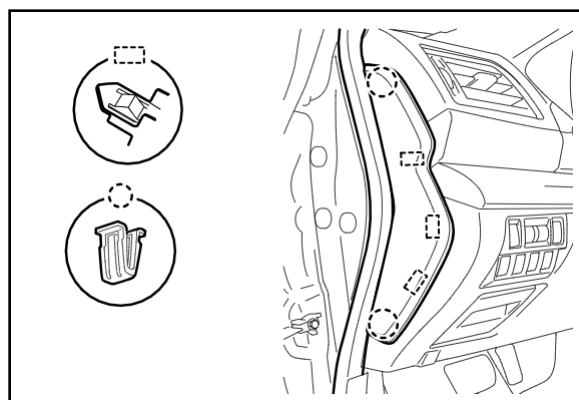
**Step 4: CAREFULLY** remove the IP end cover using the plastic trim stick. There’s a retaining clip at the top and bottom with 3 locating pins in between.

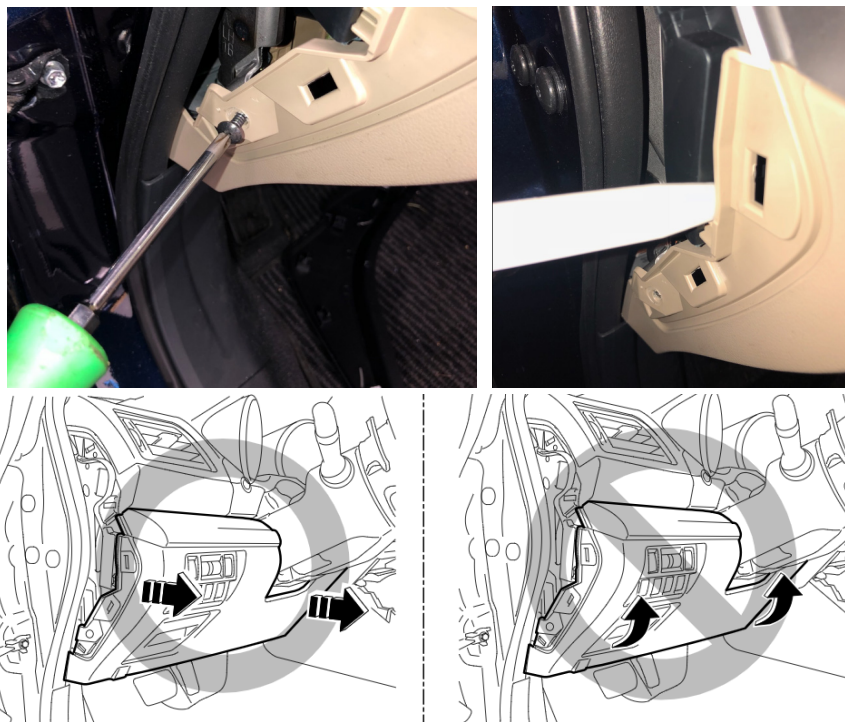
**Step 5:** Remove the phillips screw and release the 1 clip on the end portion of the trim shown in the photo. Then, **CAREFULLY** release and lower the lower IP trim panel by pulling it straight back toward you. **DO NOT** try to “peel” it up from the bottom. Leave all switches and the aspirator tube connected.

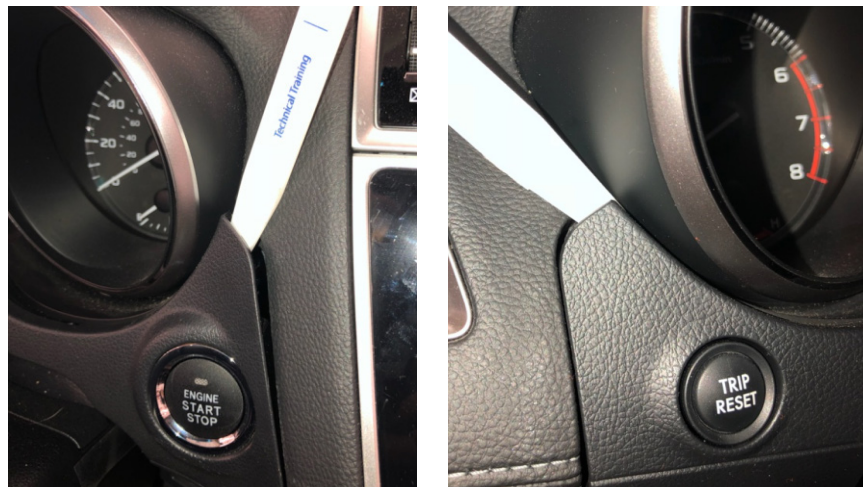
- Release the top claws on both sides using a trim stick as previously recommended.

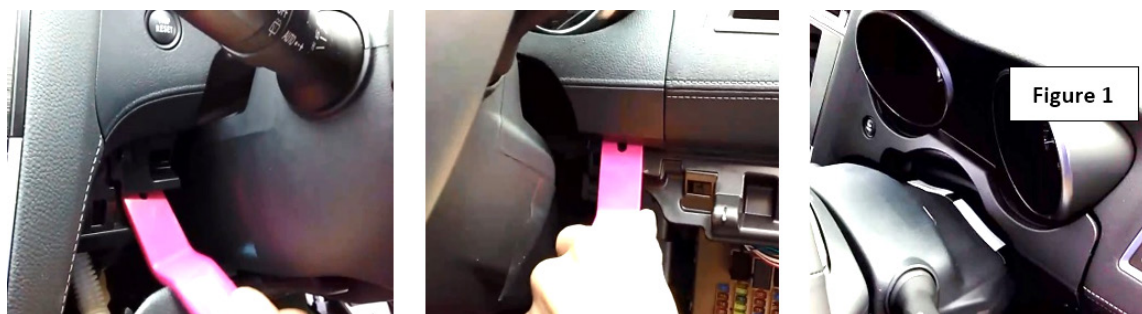
- Release the lower claws on both ends of the bezel using a trim clip removal tool as shown. When all four corners are released, the bezel will appear loose as shown in Figure 1 below BUT, there are 2 more upper / center retaining clips which must be **CAREFULLY** released from underneath before the bezel can be removed.

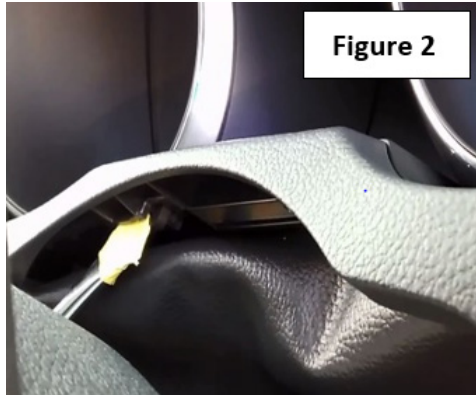
- Use a flat-blade screwdriver with protective tape added shown in Figure 2 and 3 below works well. A CAREFUL twist of the tool will release the clips. NOTE: These 2 center clips will likely require more effort to release the first time than in the future if necessary.

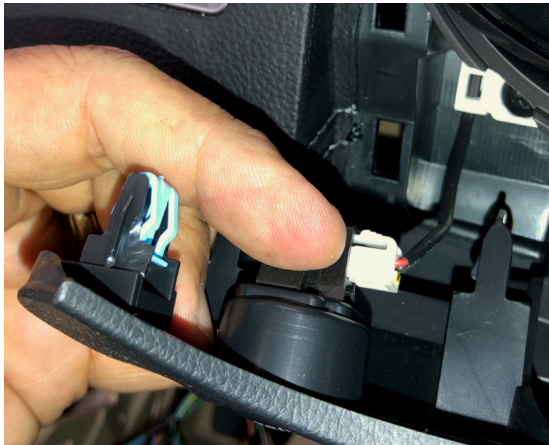
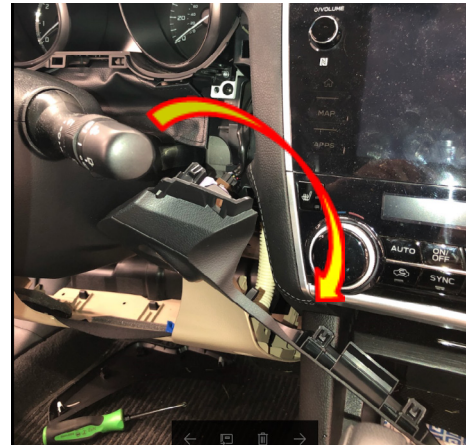
- Once the bezel is loose, disconnect the trip reset button harness connector and put the piece aside. On Push Start models, LEAVE THE START SWITCH CONNECTED and just flip the bezel over toward the radio. Cover the bezel with a clean shop cloth to make sure does not scratch the audio unit face or any surrounding trim.

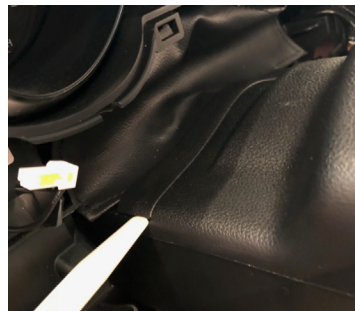
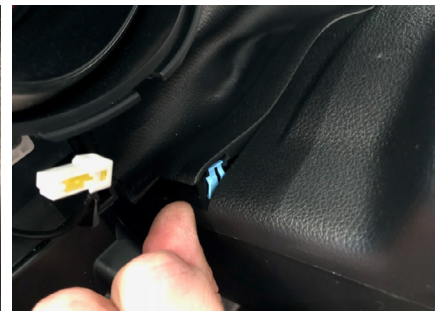
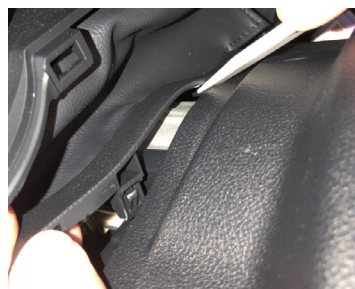
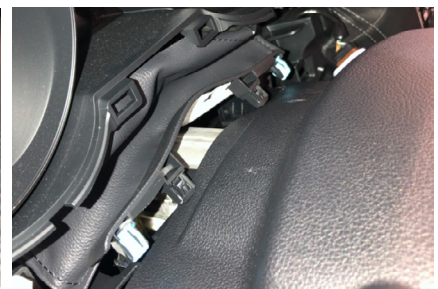
**Step 7:** Use the trim stick to release the 4 clips holding the fabric “gap cover” trim in place at the front of the steering column cover. If you have a good thumbnail, use it to create a gap for inserting the trim stick. Insert the trim stick and work your way across to remove the trim as shown in the photo sequence below. **NOTE:** The fabric is “attached” to a plastic reinforcement piece that clips onto the underside of the combination meter. Leave it attached to the combination meter. **DO NOT EVER** pull on the fabric as it is only lightly attached.

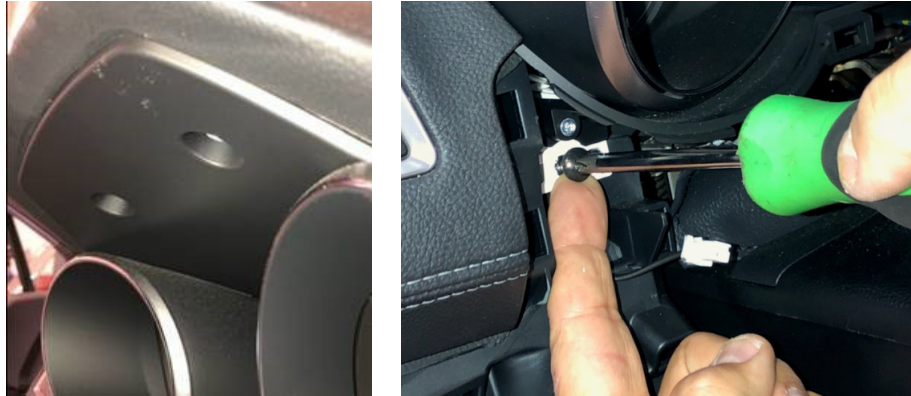
**Step 8:** Remove the 2- 10mm bolts from the underside of the visor and the 2 phillips screws on the bottom corners of the combination meter.

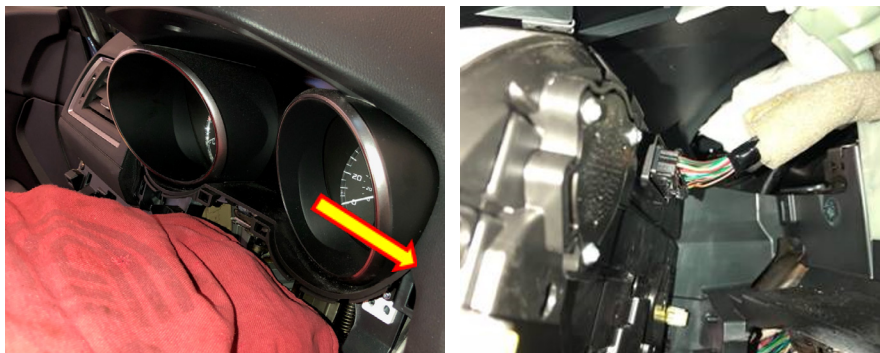
**Step 9:** Cover the steering column cover with a clean cloth or towel to protect it while removing and reinstalling the combination meter. **CAREFULLY** pull the meter toward you enough to get a hand behind it, press the lock tab on the harness connector and unplug it. There is only the one connector. Once unplugged, remove the combination meter from the IP toward the right of the steering wheel.

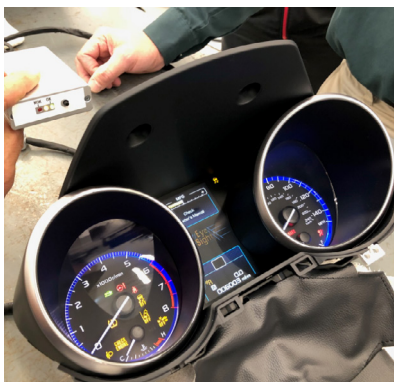
**Step 10:** Plug the AC adapter of the reflash tool into 120v AC “house current” and the combination meter connector into the meter. The meter will power up and illuminate completely. The tool’s Yellow LED will illuminate. Press the black button to start the update. It takes about 70 seconds to complete.

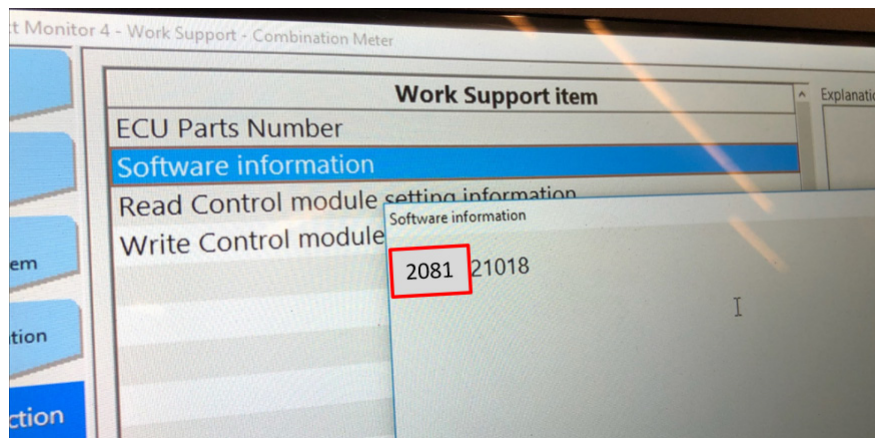
**Step 14:** Connect the SM4 and navigate to Work Support for the Combination Meter. Click on Software information and confirm the update was successful. Refer to the table below for the version information. The first 4 digits signify the version number. The photo shows a successful update of a 2017 Outback (2081). Once a successful update is confirmed, the process is complete.
