Technical Service Bulletin

Topic	Noises from Panoramic sun roof
Market area	Bentley: worldwide (2WBE),Hongkong-Macau (5HK)
Brand	Bentley
Transaction No.	2054210/2
Level	EH
Status	Released for publishing
Release date	May 17, 2019

Bentayga

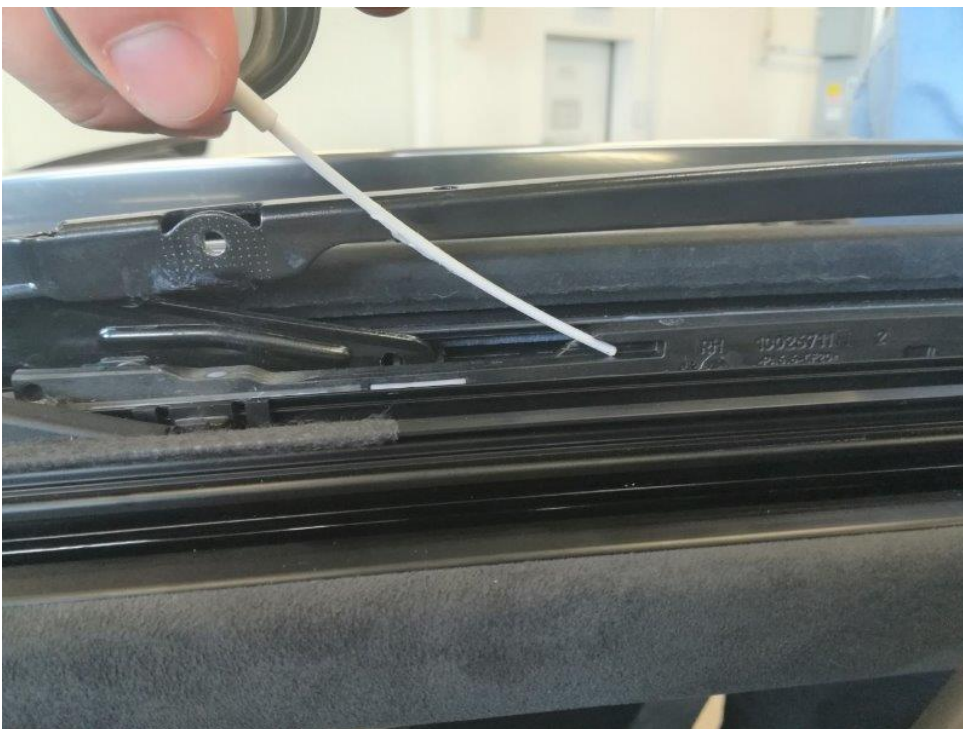
Mechanical system of sun roof frame not or insufficiently lubricated.

- The above illustration shows the right mechanical system from the inside. Here is the groove (see arrow) which also has to be sprayed once or twice.
