UPDATE FROM WARRANTY OPERATIONS

V08/V11/V16 3.0L Diesel Emission Campaigns

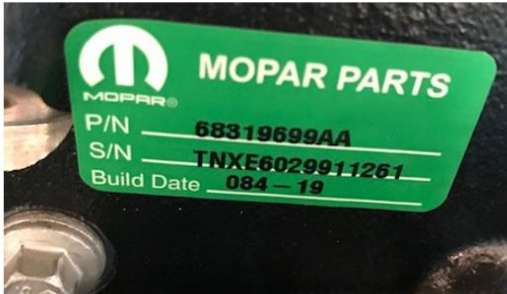
Hemi OEM vs ReMan Identification

the failed engine has a green or orange service reman tag, please use causal LOP: 09-01-70-RE. This LOP does not contain labor hours or parts allowance, but simply serves as an identifier for reman engine failure. To obtain labor time reimbursement, all applicable standard LOPs will still need to be present on the claim condition.

ReMan Engine Part Number Tag and Location. Tags will be Orange or Green.

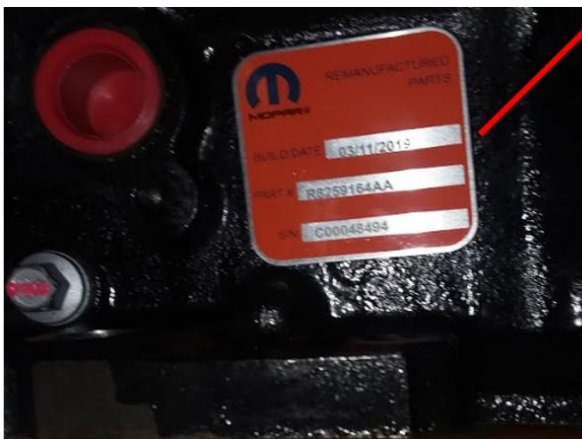
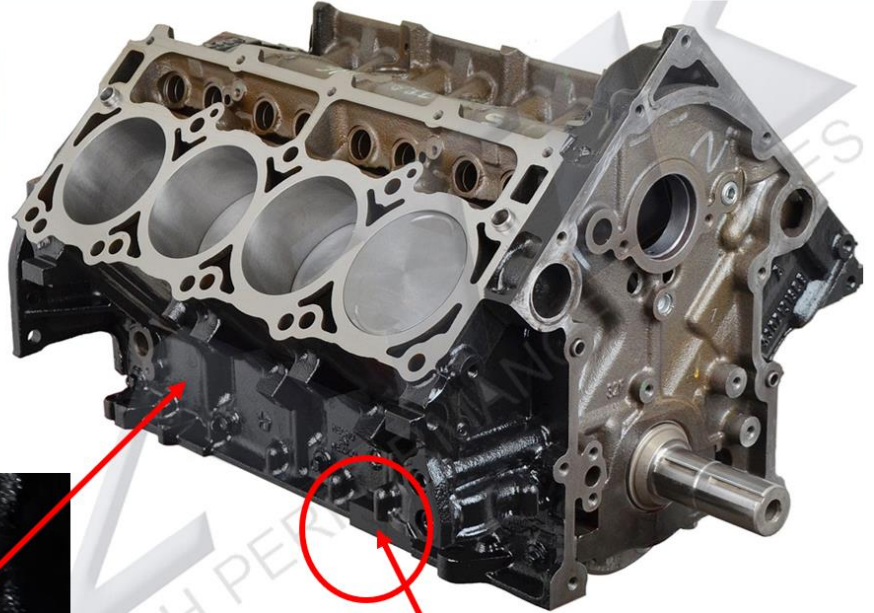
OE Engine Part Number Location

In order to identify OE vs ReMan engine warranty claims, a new causal LOP has been assigned for engine replacements. Please review the following instructions. When replacing Pentastar or Hemi engines, please record the engine part number of the **engine being removed** from the vehicle. Reference pictures of each engine for proper identification and part number location. If

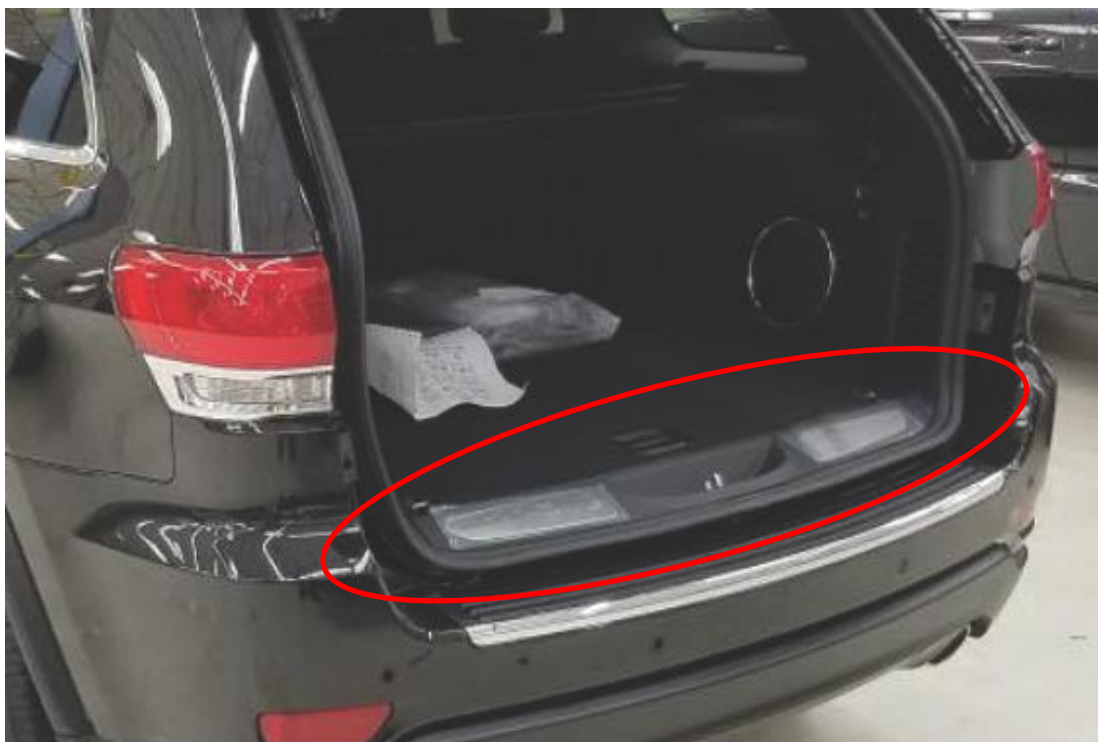
AFTER

WK – Change out the aluminum scuff plate on Limited class vehicles to the plastic Mold in color scuff plate found on the base models
