## SERVICE BULLETIN

**APPLICABILITY:** 2017-18MY Impreza  
 2018MY Crosstrek  
 2018MY Legacy and Outback  
 2018MY BRZ\*

**NUMBER:** 15-211-17R

**SUBJECT:** Reprogramming File Availability for Additional Optimization of Harman Gen 3 Audio and Navigation Head Units

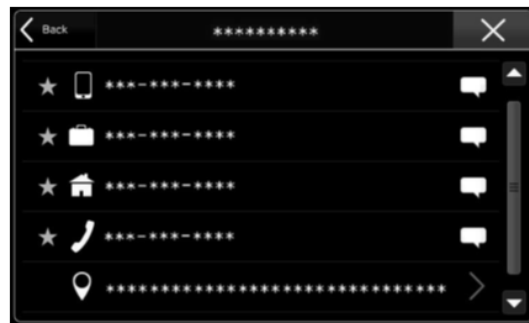
- Update to further reduce static or “noise” when listening to AM radio stations
- Update to address Navigation system “Freezing-Up” condition (gray screen / rotating loading circle)
- Update to address loss of downloaded Phone Contact list information

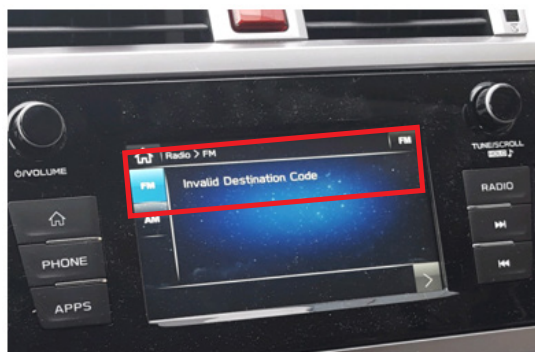
- Update to address music “skipping” concerns when using CarPlay
- Update to correct US State Route name pronunciations
- Update to address Hands-Free feature freezing during boot-up
- Update to address discrepancies between Navigation unit and Multi-Function Display (MFD) and also between the Navigation unit display and actual posted Speed Limit signage  
*\*\* Since municipalities may at any time adjust speed limits of roads or sections of roads, the driver is responsible to adjust their speed according to all posted signage. The speed information supplied is the best available at the time of map production and subject to change.*
- Update to address system freezing when searching for addresses using Voice Recognition
- Update to address music not playing automatically when connecting a USB device
- Update to address display of “Invalid Destination Code” message

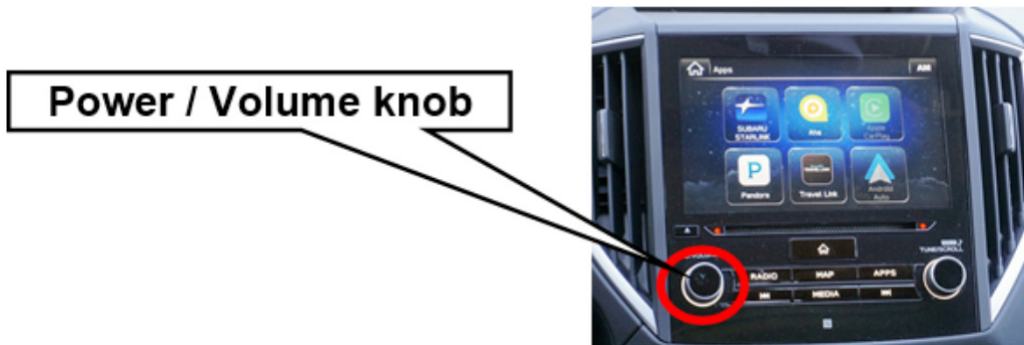
- The Mute function of the Power / Volume knob (a brief press and release of the Power / Volume knob to mute audio output) is unchanged.
- A “system reboot” function is initiated by pressing and holding the Power / Volume button for 10 seconds. This feature was included as part of the previous (11/2017) software update.

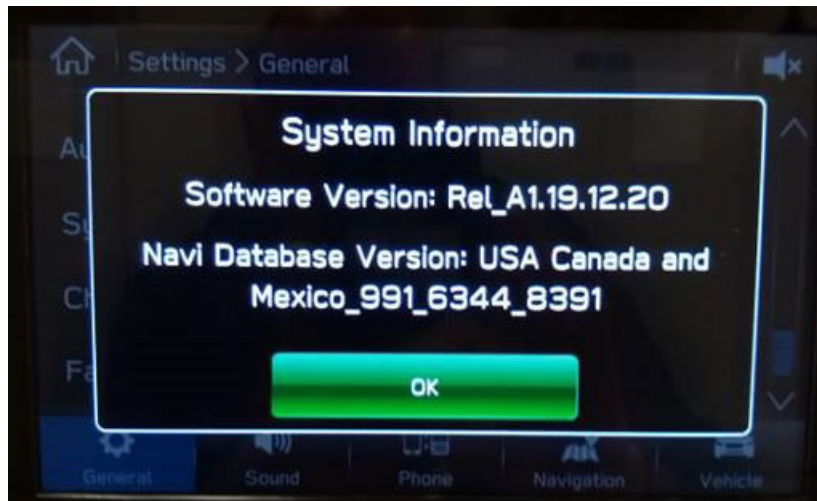
- Confirm the current Software Version ID. If the Current Version is **Rel\_A1.19.12.20**, STOP as this latest update has already been installed.

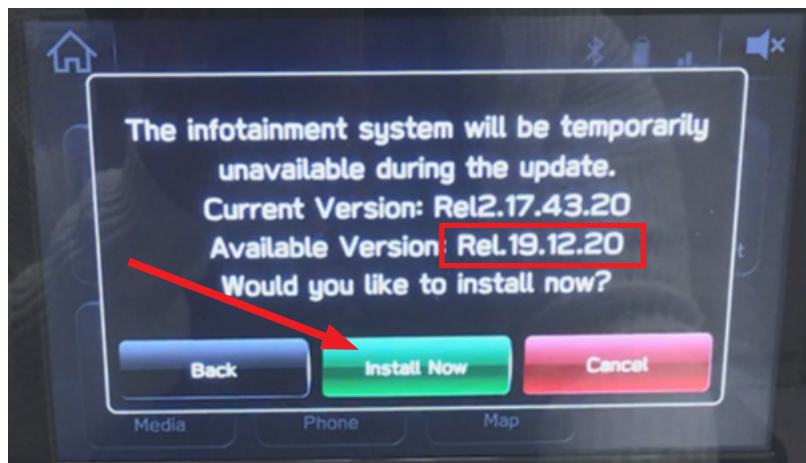
- The current and available software version information will be displayed. The Available Version I.D should be **Rel\_A1.19.12.20**.

**NOTE:** The displayed Available Version as shown below does not show the \_U0 after the Rel. This is normal.

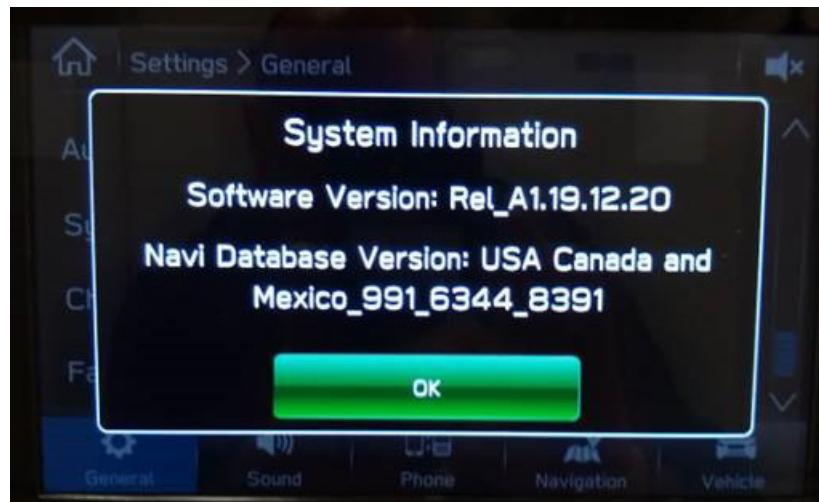
- Confirm Software Version is now “**Rel\_A1.19.12.20**”.
