SI B01 21 18  
Warranties

## **UPDATE!** N63 ENGINE: OIL CONSUMPTION CLASS ACTION SETTLEMENT DIAGNOSIS AND REPAIR PROCEDURES (VERSION 10.0)

This Service Information bulletin supersedes SI B01 21 18 **dated March 2019**

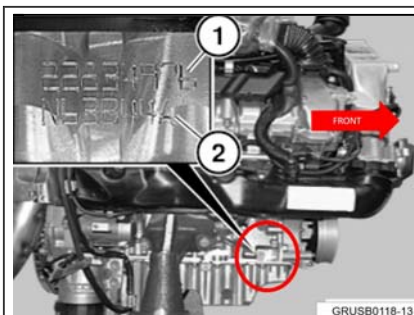
Engine serial number (1)

The engine serial number is located at the lower front right corner of the engine block.

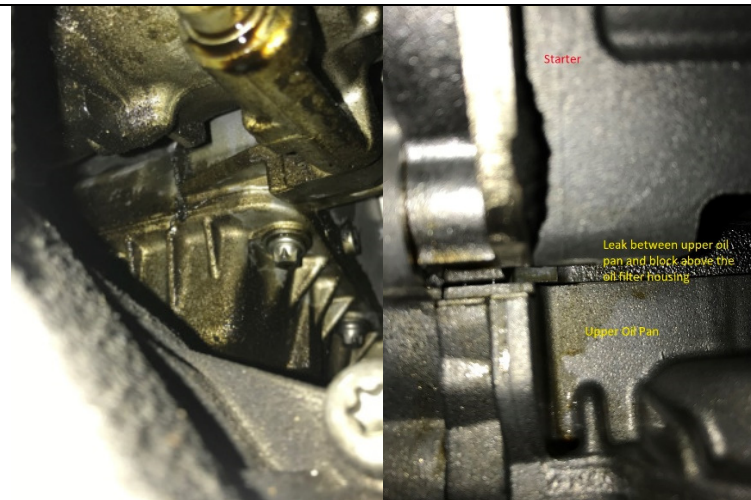
4. Inspect the upper engine oil pan for engine oil leakage.

If the upper engine oil pan is not leaking. Go to step 5.

If the upper engine oil pan is leaking. Go to step 6.

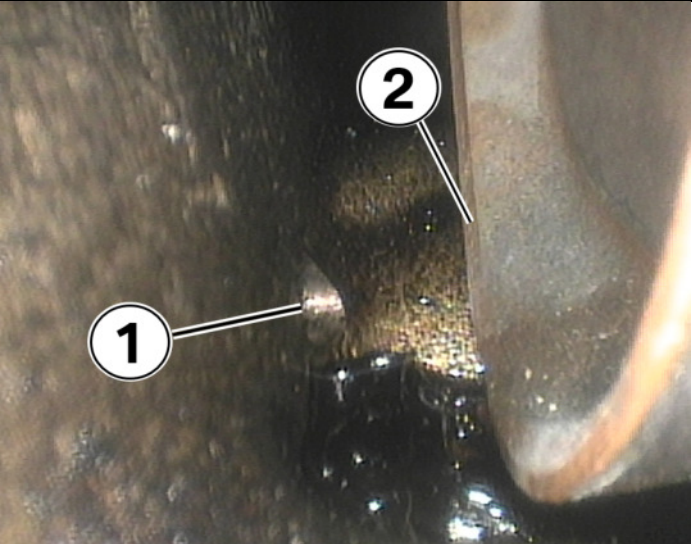
<p>A bore scope view showing a close-up of the engine valley drain hole (1) and the metal vacuum reservoir (2). The drain hole is on the left, and the reservoir is on the right.</p>	<p>Inspect the surrounding area of the engine valley drain hole (1).</p> <p>Engine valley drain hole (1)</p> <p>Metal vacuum reservoir (2) shown.</p> <p>This is a clean picture. No oil can be seen in the oil drain hole (1).</p> <p>The dark material at the bottom of the photo is dust and dirt. This material appears to be reflective but it is dry</p>

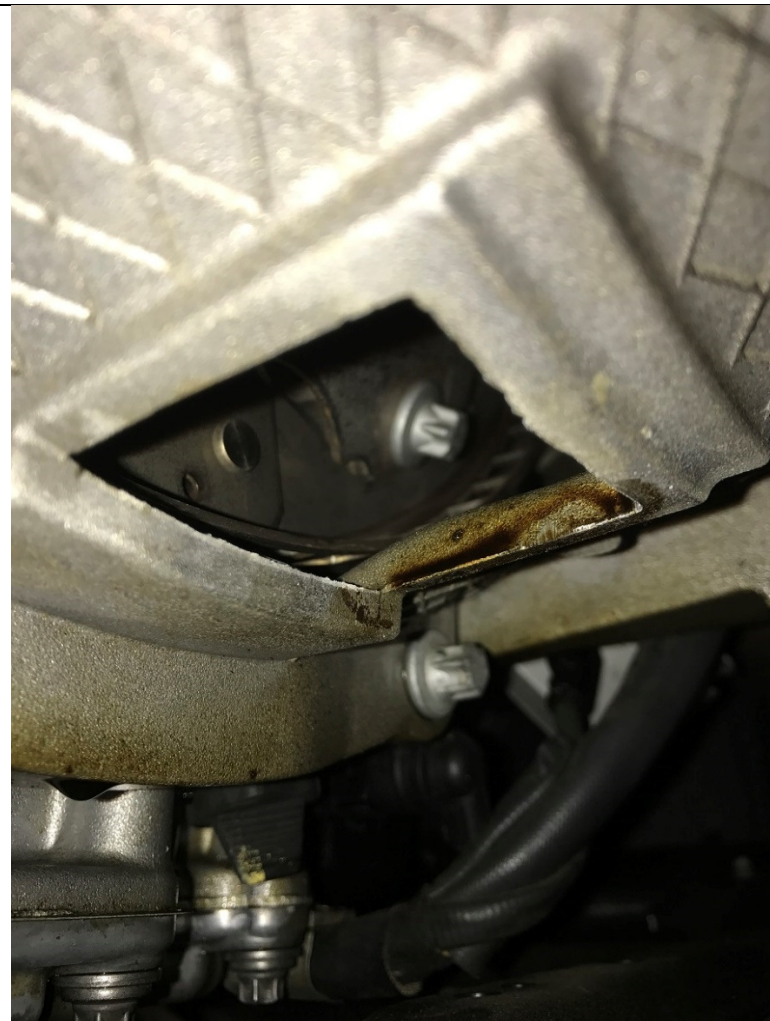
6. Inspect the lower bell housing for engine oil leakage

The lower bell housing is **not** leaking. Go to step 8.

The lower bell housing is leaking. Go to step 7.
