Service Bulletin

Bulletin No.: 00-06-01-012J

Subject: Use of Surface Conditioning Disks When Cleaning Gasket Sealing Surfaces and/or Reused Parts

Models: 2020 and Prior GM Passenger Cars and Trucks including Silverado 4500HD, 5500HD and 6500HD (Excluding Chevrolet Medium Duty Low Cab Forward Equipped with Diesel Engine).

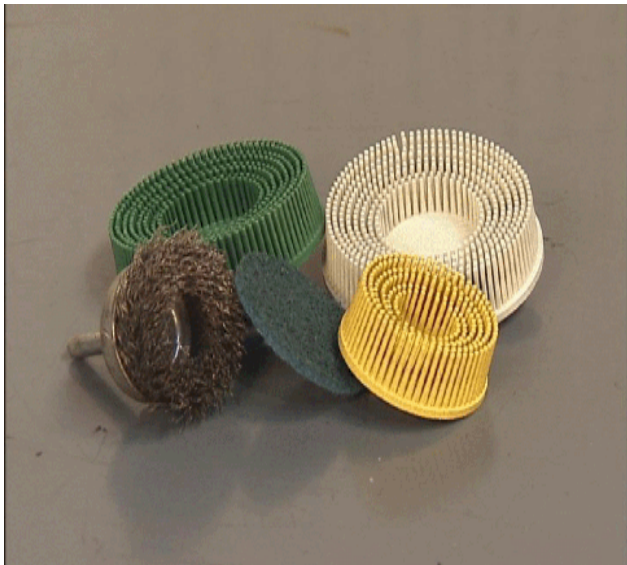
2726943

Notice: Do not use abrasive pad/bristle devices to clean the gasket surfaces of any engine, transmission, transfer case and axles as well as any other component that contains lubricant. Abrasive pads should not be used for some of the following reasons:

- Abrasive pads will produce fine grit that the oil filter will not be able to remove from the oil. THIS GRIT IS ABRASIVE AND HAS BEEN KNOWN TO CAUSE INTERNAL ENGINE DAMAGE. Abrasive pads can easily remove enough material to round cylinder head surfaces. This has been known to affect the gasket's ability to seal, especially in the narrow seal areas between the combustion chambers and coolant jackets.

- Abrasive pads, wire and abrasive rubber finger wheels can also remove enough metal to affect cylinder head, block, oil pan rail, and intake manifold runner flatness, which can cause coolant and oil leaks and air leaks. It takes about 15 seconds to remove 0.203 mm (0.008 in) of metal with an abrasive pad.

General Motors recommends the use of a razor blade or plastic gasket scraper to clean the gasket surface on components that are to be reused. When cleaning gasket surfaces, please note the following:

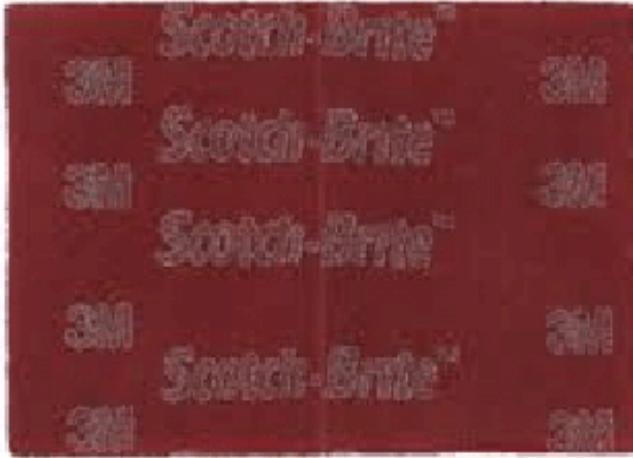
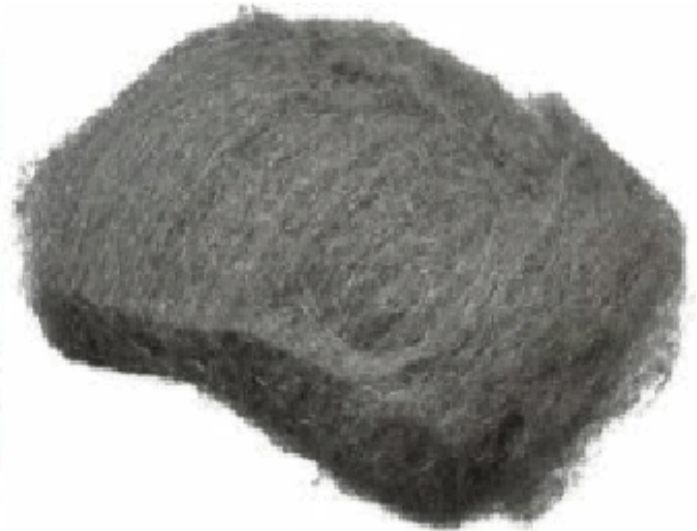
The use of an abrasive hand pads and/or steel wool can also create imperfections in the metal and therefore are not recommended for use when cleaning surfaces.

When cleaning gasket sealing surfaces and/or cleaning parts that are to be reused, surface conditioning disks, hand pads, or steel wool (typically constructed of woven fiber, steel or molded bristles) that contain abrasives, such as a high amount of Aluminum Oxide, should NOT be used.

The use of such surface conditioning items dislodges Aluminum Oxide (from the disk) and metal particles (from steel wool), which can lead to premature engine bearing failure.
