P20EE (diagnostic troubleshooting code) SOLUTION - NOX CONVERSION EFFICIENCY

Prevost vehicles

B13R (9700 us/can)

SP18-35D

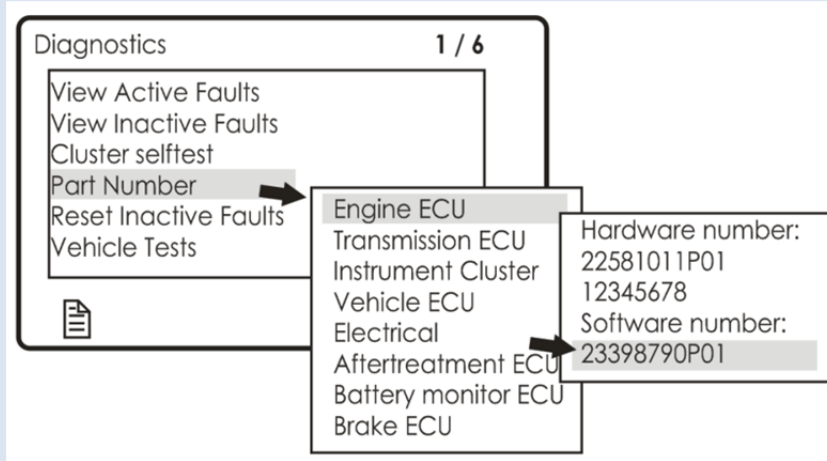
- 7 Check and record the engine ECU (a.k.a. Engine Control Module ECM) software number.
To do so, check in the dashboard DID. Select DIAGNOSTICS > PART NUMBER > ENGINE ECU
