SERVICE BULLETIN

APPLICABILITY: 2017-18MY Impreza
 2018MY Crosstrek
 2018MY Legacy and Outback
 2018MY BRZ*

NUMBER: 15-211-17R

SUBJECT: Reprogramming File Availability for Additional Optimization of Harman Gen 3 Audio and Navigation Head Units

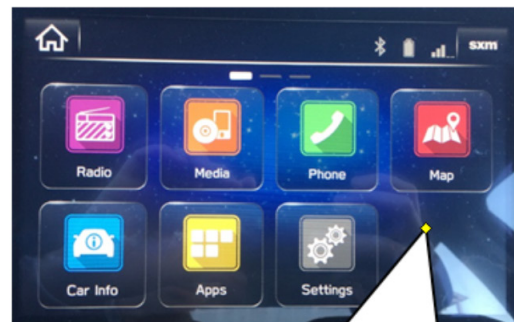
Normal HOME screen with icons

- Update for condition where only the star field background is displayed (without icons) after the HOME button is pressed.
