SERVICE BULLETIN

Classification: AT18-003d	Reference: NTB18-058d	Date: October 9, 2019
------------------------------	--------------------------	--------------------------

2013-2017 SENTRA AND VERSA SEDAN, AND 2014-2017 VERSA NOTE; ENHANCED DIAGNOSTIC LOGIC FOR CVT

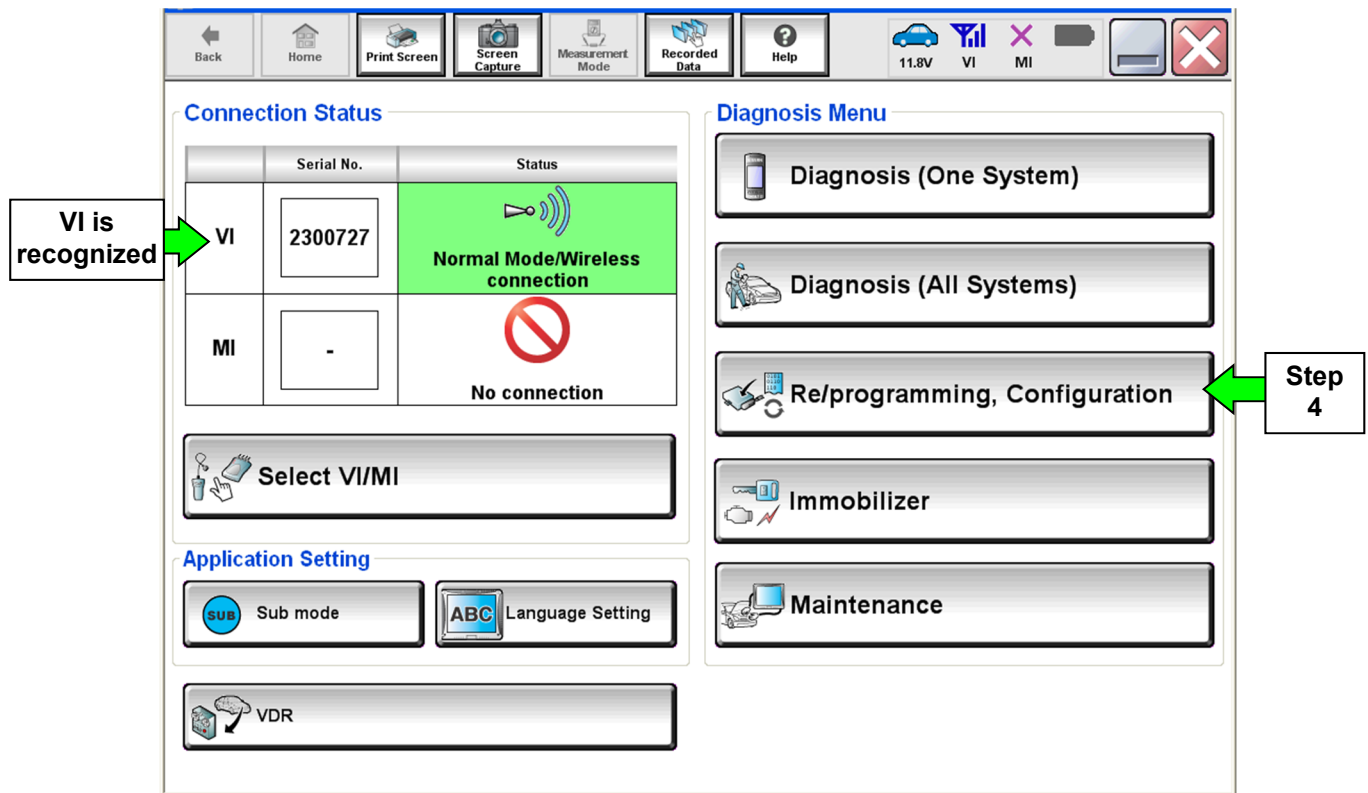
Figure 1

1. Connect the CONSULT PC to the vehicle to begin the reprogramming procedure.
2. Start C-III plus.
3. Wait for the plus VI to be recognized.
 - The serial number will display when the plus VI is recognized.
4. Select **Re/programming, Configuration**.

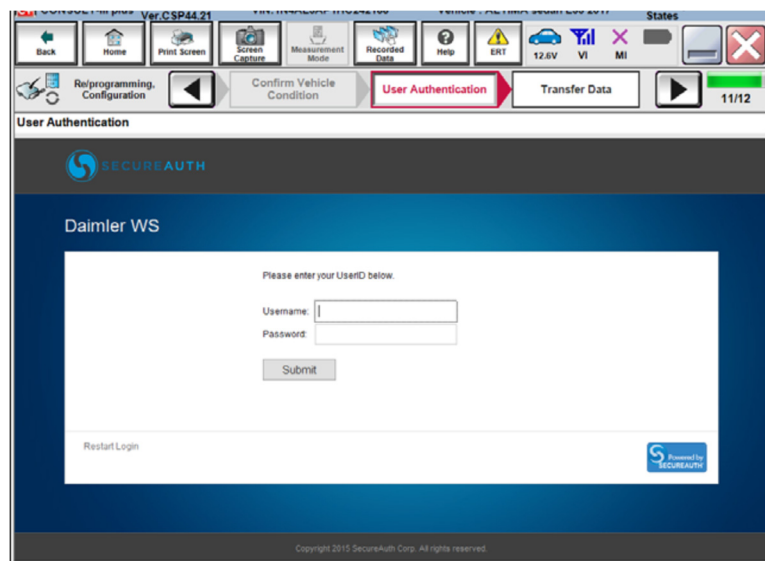
Figure 4

- Before reprogramming will start, you will be required to enter your User Name and Password.
 - The CONSULT PC must be connected to the Internet (Wi-Fi or cable).
 - If you do not know your User Name and Password, contact your Service Manager.
