# SERVICE BULLETIN

Classification: EC18-028b	Reference: NTB18-062b	Date: October 24, 2019
------------------------------	--------------------------	---------------------------

## 2018 ARMADA AND TITAN; MIL ON WITH DTC P0138 AND/OR P0158

- APPLIED VEHICLES:** 2018 Armada (Y62)  
2018 Titan (A61)  
2018 Titan XD (A61)
- APPLIED ENGINE:** VK56VD (gasoline V8)

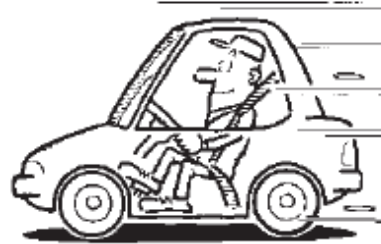
Figure A

- Connect a battery maintainer or smart charger set to reflash mode or a similar setting. If the vehicle battery voltage drops below 12.0V or above 15.5V during reprogramming, the ECM may be damaged.
- Be sure to turn OFF all vehicle electrical loads. If a vehicle electrical load remains ON, the ECM may be damaged.
- Be sure to connect the AC Adapter. If the CONSULT PC battery voltage drops during reprogramming, the process will be interrupted and the ECM may be damaged.
- Turn OFF all external Bluetooth® devices (e.g., cell phones, printers, etc.) within range of the CONSULT PC and the plus VI. If Bluetooth® signal waves are within range of the CONSULT PC and plus VI during reprogramming, reprogramming may be interrupted and the ECM may be damaged.

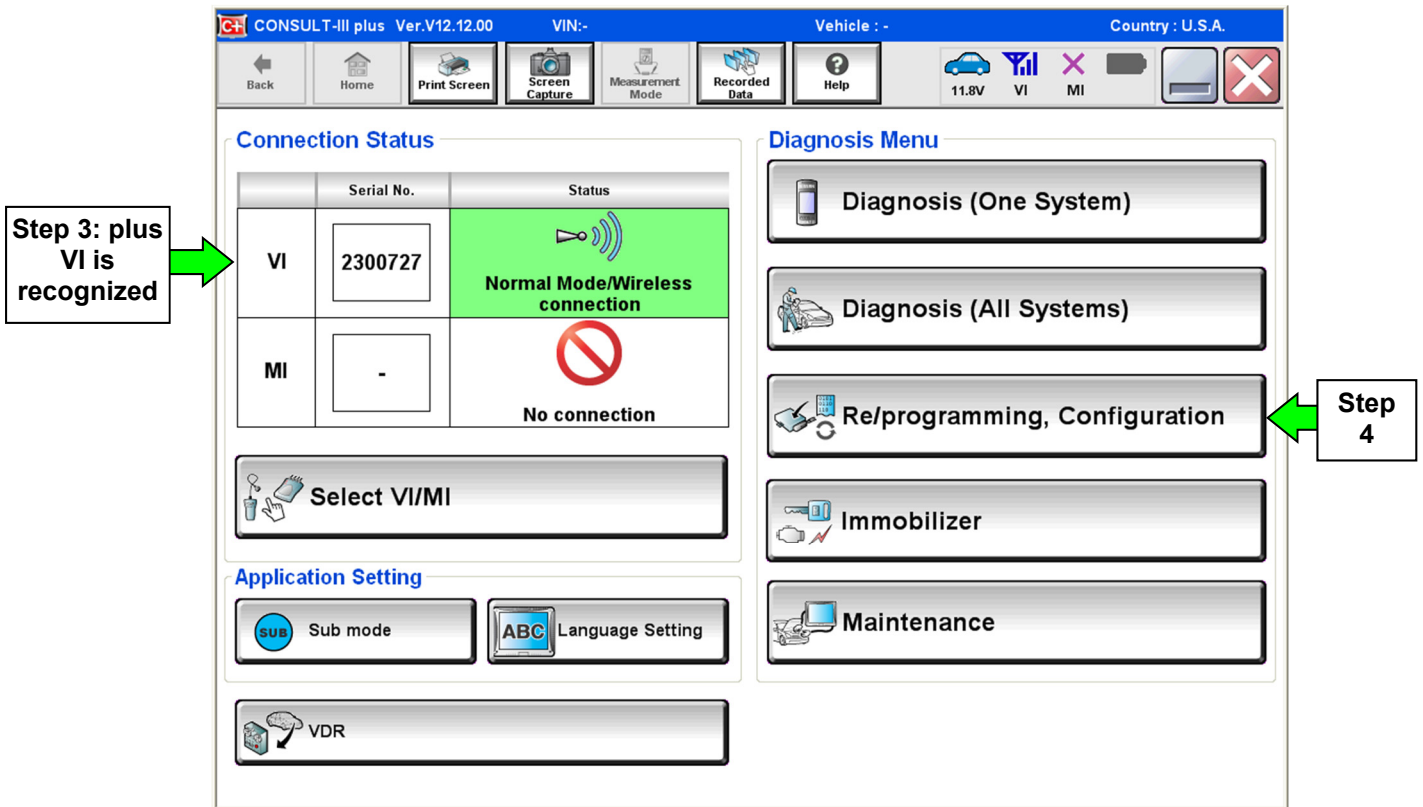
Figure 1

1. Connect the CONSULT PC to the vehicle to begin the reprogramming procedure.
2. Start C-III plus.
3. Wait for the plus VI to be recognized / connected.
  - The serial number will display when the plus VI is recognized / connected.
4. Select **Re/programming, Configuration**.

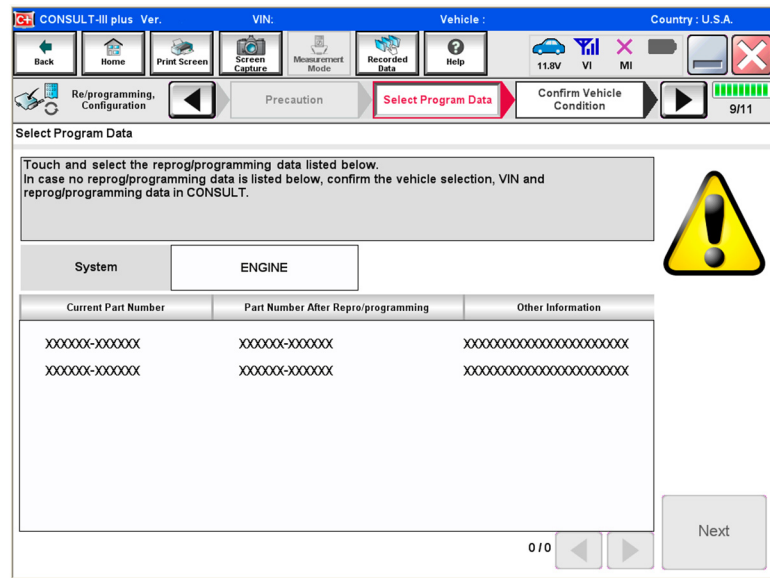
- In some cases, more than one new P/N for reprogramming is available.
  - In this case, the screen in Figure 3 displays.
  - Select and use the reprogramming option that **does not** have the message “Caution! Use ONLY with NTBXX-XXX”.
- If you get this screen and it is blank (no reprogramming listed), it means there is no reprogramming available for this vehicle. Close C-III plus and refer back to ASIST for further diagnosis.

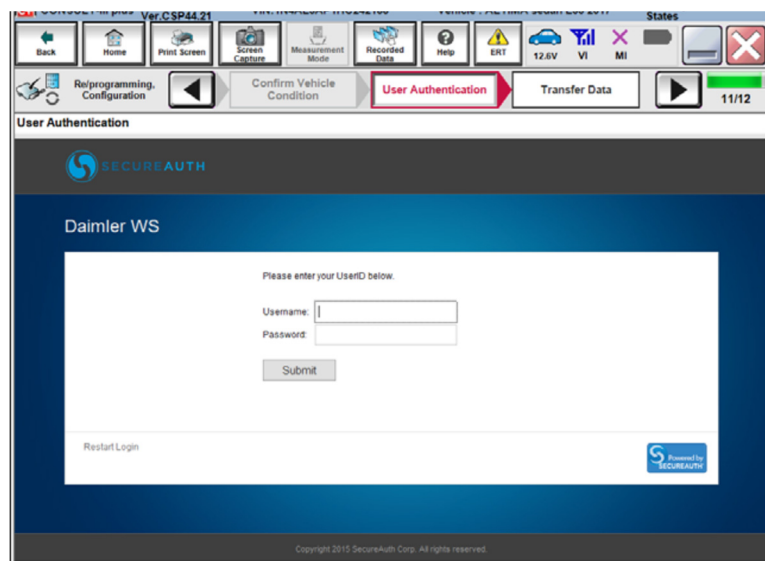
Figure 4

- Before reprogramming will start, you will be required to enter your User Name and Password.
  - The CONSULT PC must be connected to the Internet (Wi-Fi or cable).
  - If you do not know your **Username** and **Password**, contact your service manager.

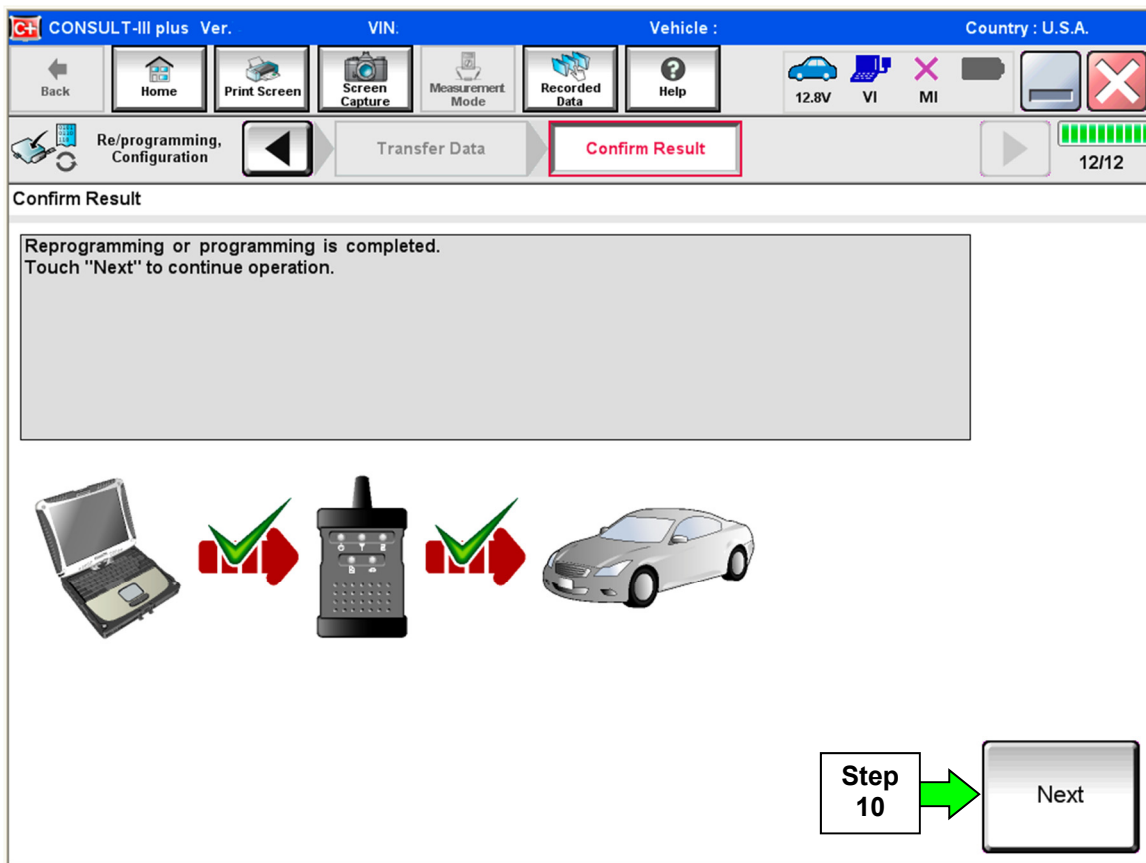
8. When the screen in Figure 5 displays, reprogramming is complete.

**NOTE:** If the screen in Figure 5 does not display (reprogramming does not complete), refer to the information on page 7.

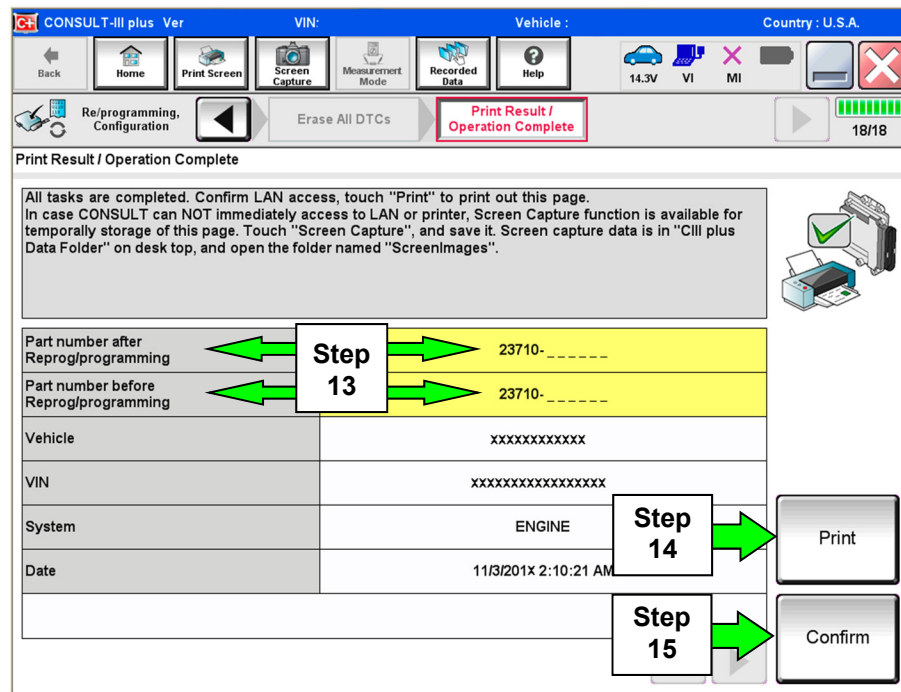
12. When the entire reprogramming process is complete, the screen in Figure 8 will display.
13. Verify the before and after part numbers are different.
14. Print a copy of this screen (Figure 8) and attach it to the repair order for warranty documentation.
15. Select **Confirm**.
