NUMBER: 08-019-19 REV. B

UGQ Radio Enhancements

This bulletin involves inspecting and if required, updating the radio software level to ****2.5****.

2018 (WK) Jeep Grand Cherokee

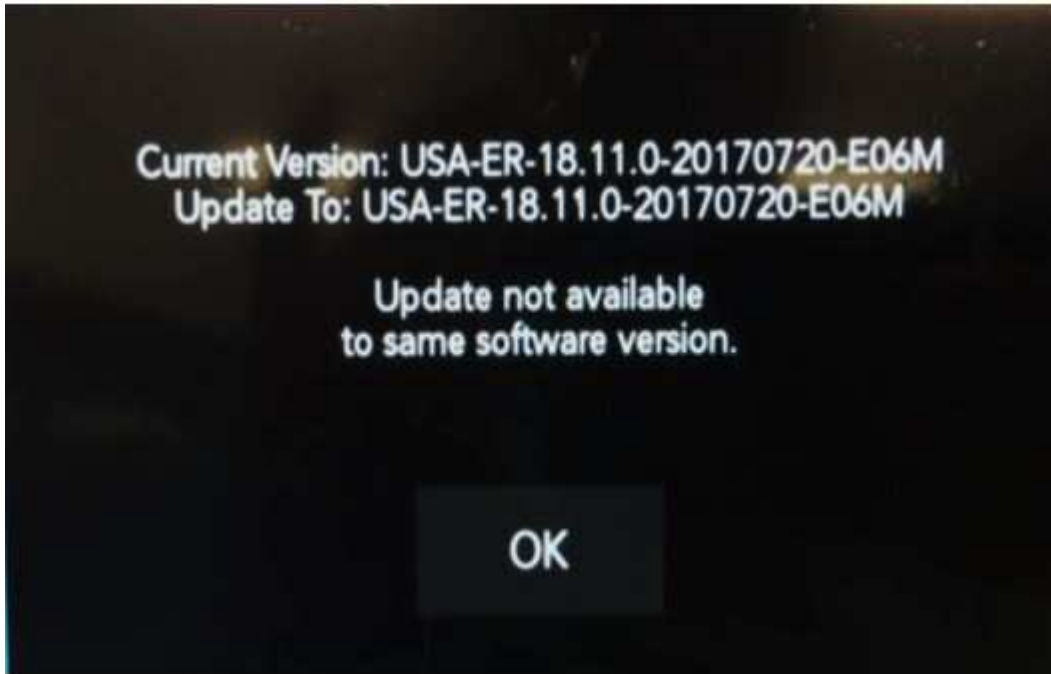
Fig. 8

Radio Software Has Been Updated (figure is for reference only).

14. After the update has completed, the radio will shut down. With the USB flash drive still inserted in the USB port, turn the ignition back to the run position. If the radio has been updated correctly, the screen in (Fig. 8) will be displayed. Press “OK” and remove the USB flash drive.
