PRODUCT CAMPAIGN BULLETIN

APPLICABILITY: 2018 Model Year Legacy and Outback Vehicles **NUMBER:** **WTW-82R**
SUBJECT: Combination Meter Reprogramming **NHTSA ID:** 18V-773
DATE: 12/11/18
REVISED: 11/08/19

Subaru of America, Inc. (Subaru) is recalling all 2018 model year Legacy and Outback vehicles to reprogram the combination meter software to correct an error in the driving range indicator calculation in the multi-information display. A total of 228,648 U.S. vehicles will be affected by this recall.

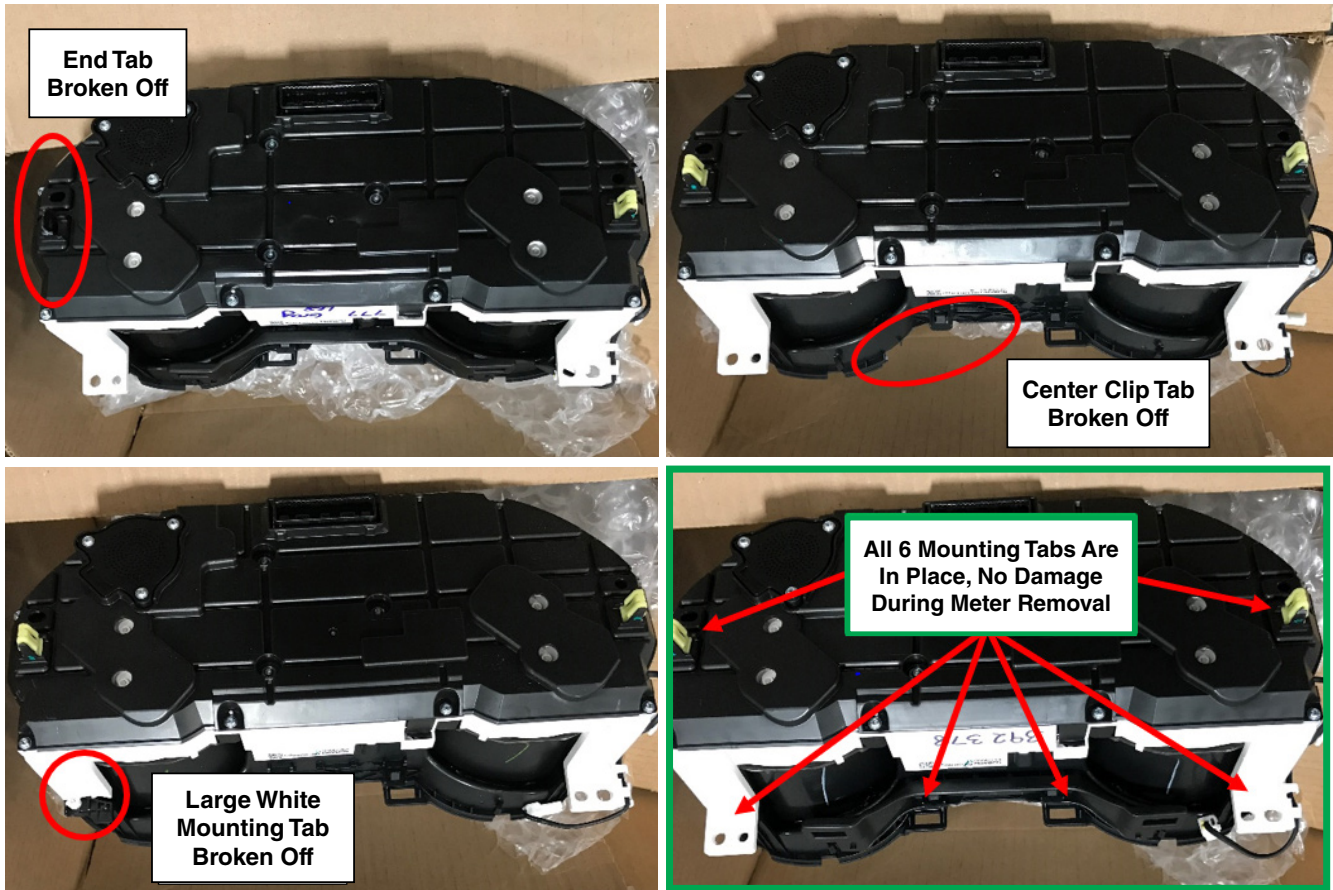
REMINDER: Before proceeding to **Step 6** below, it cannot be stressed enough for Technicians to **TAKE THEIR TIME** when removing and reinstalling the combination meter. The photos below illustrate what can happen to the meter assembly when not performing these steps **CAREFULLY**. These 3 examples all show damage caused by outside influence which is not a matter for warranty.

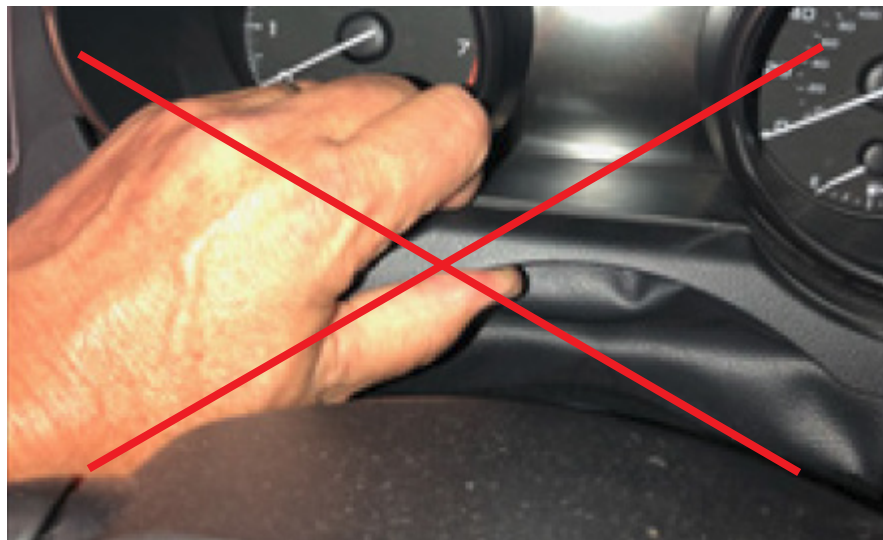
Reports of damaged meter housings as shown in the example photos below have necessitated revisions to this step.

Step 6: NOTE: Previously, the removal procedure showed releasing the top claws on each end then grasping the bezel with the thumb and forefinger and pulling straight back to release the 2 center retaining clips.

- Release the top claws on both sides using a trim stick as previously recommended.

- Release the lower claws on both ends of the bezel using a trim clip removal tool as shown. When all four corners are released, the bezel will appear loose as shown in **Figure 1** below **BUT**, there are 2 more upper / center retaining clips which must be **CAREFULLY** released from underneath before the bezel can be removed.
