Abnormal Buzz/Groan Noise at 20 – 30 mph From Front Transfer Case

Service Category Drivetrain

Section Transfer/4wd/Awd

YEAR(S)	MODEL(S)	ADDITIONAL INFORMATION
2019	RAV4

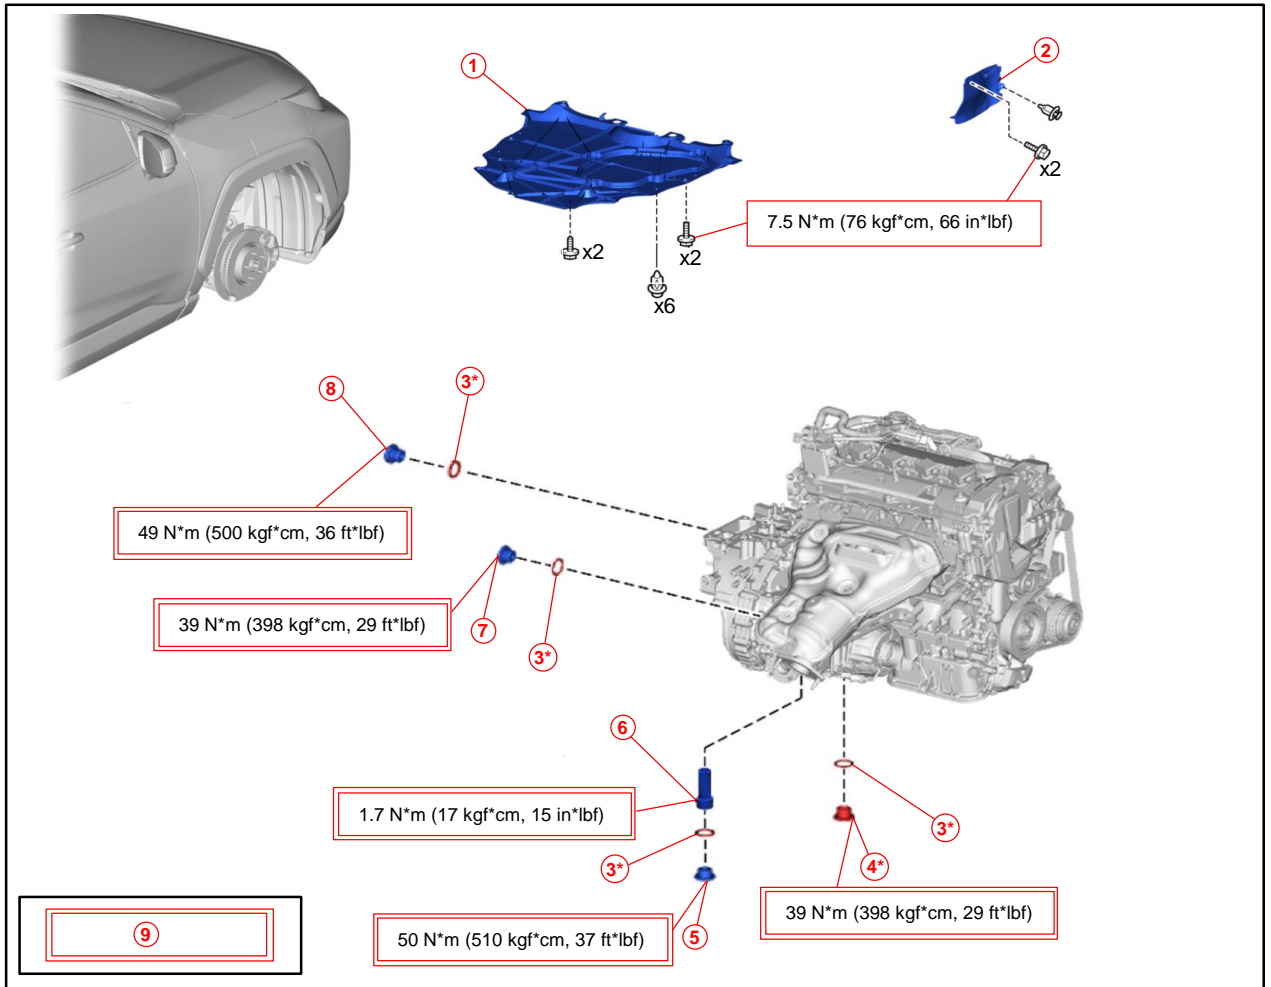
Component Overview (One of Two)

*Component to be replaced.

1	No. 2 Engine Under Cover Assembly
2	Front Fender Apron Seal RH
3	Gasket*
4	Transfer Drain Plug
5	Overflow Plug

6	No. 1 Transmission Oil Filter Tube
7	Transfer Filler Plug
8	Refill Plug
9	Torque Specification

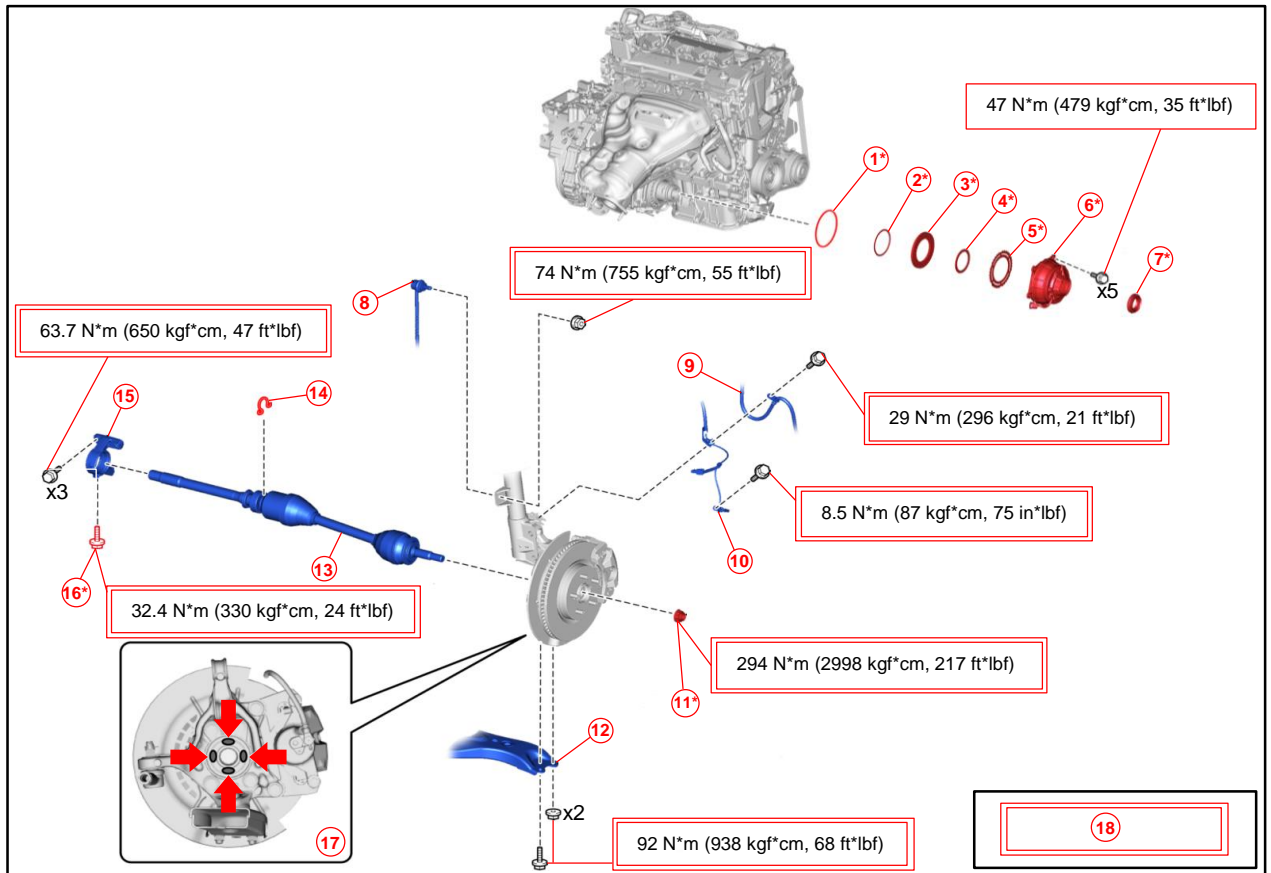
Component Overview (Two of Two)

*Component to be replaced. (Component is part of the front transfer case electro-magnetic clutch assembly.)

1	O-ring
2	Shim*
3	Armature Plate*
4	Thrust Roller Bearing*
5	Outer Plate*
6	Cover*
7	Front Transfer Case Oil Seal (MP Grease)
8	Front Stabilizer Link Assembly RH
9	Front Flexible Hose

10	Front Speed Sensor RH
11	Front Axle Shaft Nut RH (Do NOT Apply Lubricant to Threaded Parts)
12	Front Lower No. 1 Suspension Arm Assembly RH
13	Front Drive Shaft Assembly RH
14	Drive Shaft Bearing Bracket Hole Snap Ring
15	Drive Shaft Bearing Bracket
16	Bolt
17	Toyota Body Grease W (Application Area)
18	Torque Specification

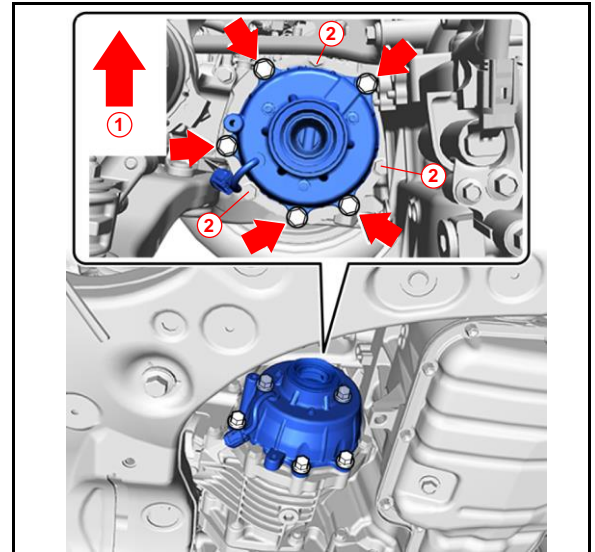
Figure 2.

1	Vehicle Upward
2	Bolt (Do NOT Remove)

- B. Remove the five bolts and electro-magnetic clutch assembly cover.
- Do NOT remove the three bolts attaching the ring gear assembly housing to the transfer case.

Gently remove the cover to prevent the disconnect shaft from being pulled out with the electro-magnetic clutch assembly.

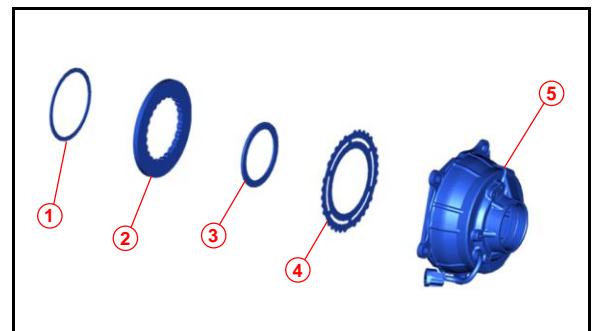
Figure 3.

1	Shim
2	Armature Plate
3	Thrust Roller Bearing
4	Outer Plate
5	Cover

- C. Remove the shim, armature plate, thrust roller bearing, outer plate, and cover.
- D. Mark and store the five removed components in a container for removed components to avoid reinstalling them in error.

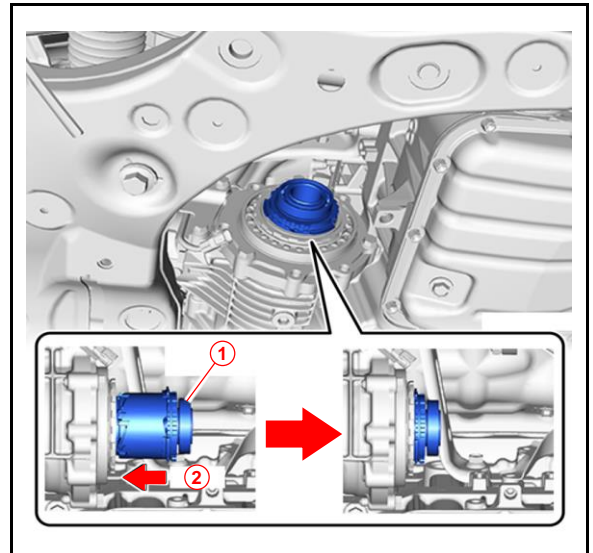
Figure 4.

1	Shaft
2	Push

- E. If the disconnect shaft is pulled out together with the electro-magnetic clutch cover, push it toward the vehicle inner side (automatic transaxle side).

Make sure to push the disconnect shaft back to its original position to ensure proper installation of the NEW electro-magnetic clutch.

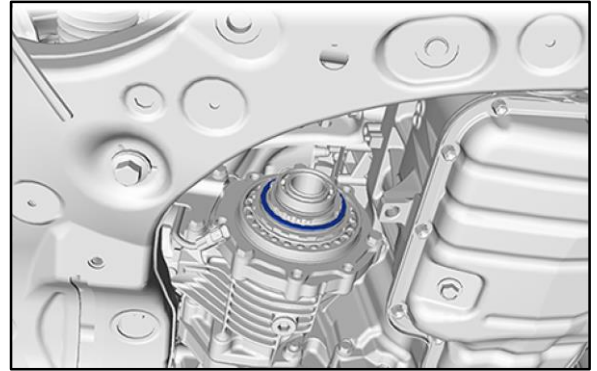
Figure 9.

AFTER proper installation, the engraved mark should NOT be visible.

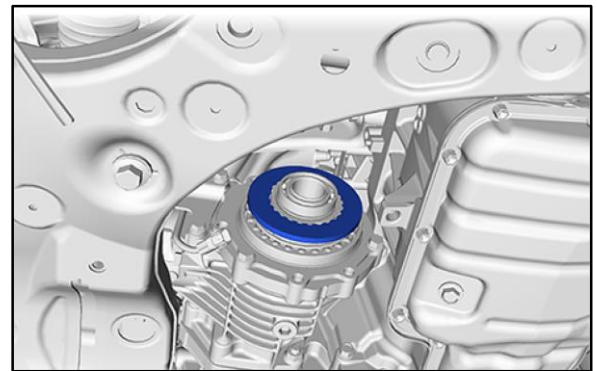
Figure 10.

AFTER proper installation, the engraved mark should NOT be visible.

- D. Install the NEW armature plate to the front transfer case with its engraved mark surface facing the vehicle inner side (automatic transaxle side).

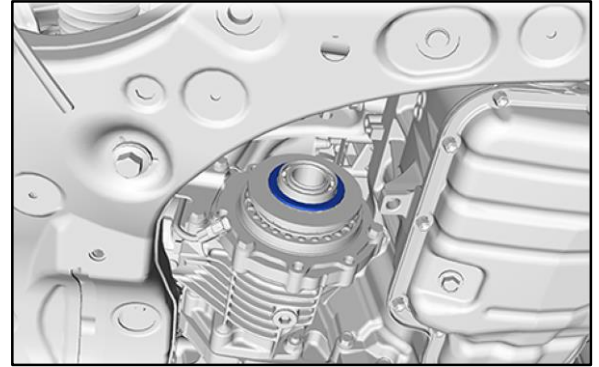
Figure 11.

AFTER proper installation, the engraved mark should NOT be visible.
