**Complaint - Cylinder Head Cover Near the Injector Holes Leaking: Subsequent work on cylinder head (180/18)**

Revision: **This bulletin replaces bulletin Group 1, #180/18, dated March 7, 2019.**  
This revision includes additional vehicle types.

Vehicle Types: **Cayenne (9YA)/Cayenne E-Hybrid (9YA)/Cayenne S (9YA)**

Subject: **Cylinder head cover**

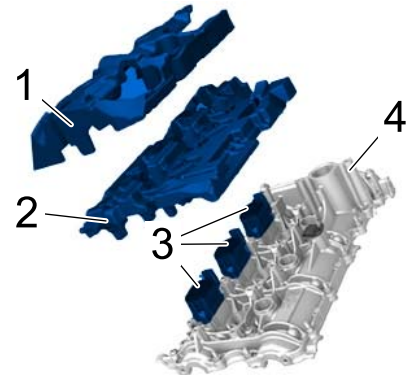
*Component overview of cylinder head cover*

- 1** – Insulation on top of cylinder head cover
- 2** – Insulation on bottom of cylinder head cover
- 3** – Solenoid hydraulic valve for valve lift adjustment
- 4** – Cylinder head cover
