Hendrickson Lift Axle Hardware, Retorque
VN, VHD

SP 656-001, Hendrickson Lift Axle Hardware, Retorque

(December 2019)

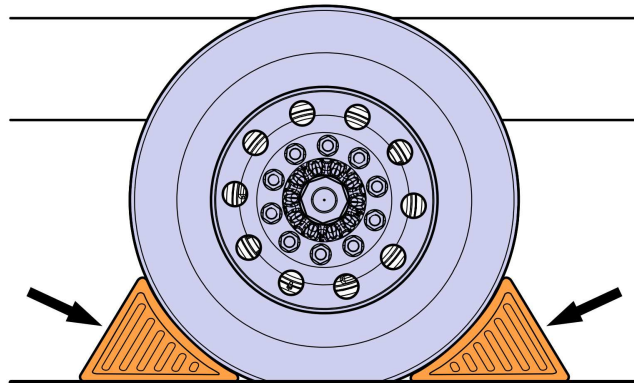
W7086748

For certain Volvo VN and VHD trucks built between 01/01/2017 and 10/02/2019, the lift arm fasteners of Hendrickson lift axle may have not been properly tightened. A new improved torque procedure has been introduced to maintain and distribute torque properly on the hardware attaching the Hendrickson Lift Axle to the brackets. Follow the repair instructions outlined in this document for retorquing the indicated fasteners.

- 1 Park the vehicle on a level surface.
- 2 Apply the parking brake.
- 3 Place the transmission in neutral or park.
- 4 Install the wheel chocks.

5 Torque tighten the fasteners.
