TECH TALK

Volume 206, March, 2014

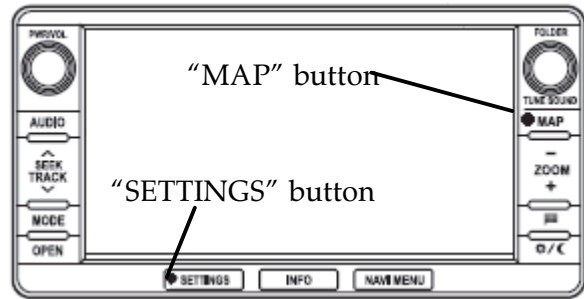
UNLOCKING THE HANDS FREE PASSCODE ON 2014 MODELS WITH MMCS NAVIGATION — All 2014 with MMCS navigation (does not apply to MMES in 2014 Mirage). The procedure for unlocking the hands free passcode on the 2014 MMCS Navigation system is different than for the 2007-13 system. Use the following steps to unlock the passcode.

- Turn the ignition to the ON position
- Turn the NAVI on
- Press and hold the MAP and SETTINGS buttons for at least 3.5 seconds to enter “Service” mode

- Select “Hands Free Module” from the “Service” menu

- Select “UNLOCK” on the “Hands Free Module” screen.

- Touch the “Back” button to exit “Service” mode.
