## SERVICE BULLETIN

**APPLICABILITY:** 2017-18MY Impreza  
 2018MY Crosstrek  
 2018MY Legacy and Outback  
 2018MY BRZ\*

**NUMBER:** 15-211-17R  
**DATE:** 06/13/17  
**REVISED:** 01/03/20

**SUBJECT:** Reprogramming File Availability for Additional Optimization of Harman Gen 3 Audio and Navigation Head Units

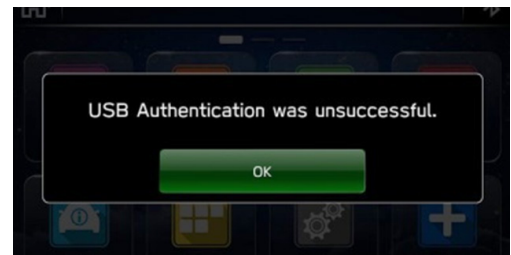
**CAUTION: NEVER** attempt to install this software on any 2019 MY vehicles as they are equipped with Gen 3.1 Audio/Navigation systems. This update is **ONLY** for models equipped with Gen 3.0 Audio/Navigation systems. Should an attempt be made to install any of these files into a Gen 3.1 head unit, the authentication error screen to the right will be displayed.

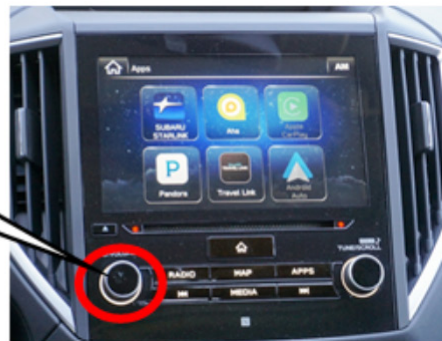
- The Mute function of the Power / Volume knob (a brief press and release of the Power / Volume knob to mute audio output) is unchanged.
- A “system reboot” function is initiated by pressing and holding the Power / Volume button for 10 seconds. This feature was included as part of the previous (11/2017) software update.
