# SERVICE BULLETIN

Classification: EL19-069a	Reference: NTB20-002a	Date: January 31, 2020
------------------------------	--------------------------	---------------------------

## 2019 SENTRA; STEERING WHEEL AUDIO SWITCHES INTERMITTENTLY INOPERATIVE

**APPLIED VEHICLE:** 2019 Sentra (B17) – S model only  
**APPLIED VIN:** Vehicles Built before 3N1(\*)B7AP(\*)K(\*)432870  
**APPLIED DATE:** Vehicles Built before October 10, 2019

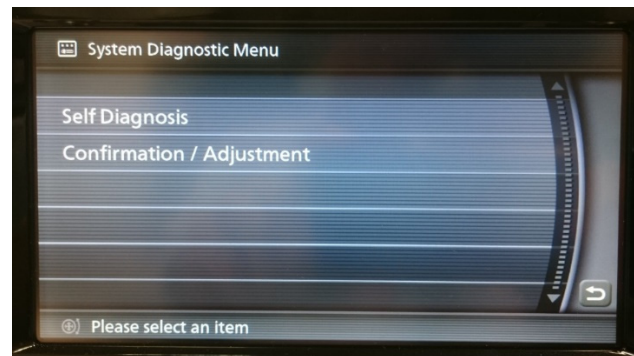
1. Turn the ignition ON.
2. Turn the audio system OFF.
3. Access the System Diagnostic Menu as follows:
  - Press and hold the **MENU** button.
  - Turn the **VOLUME** knob 40 or more clicks.
  - The screen in Figure 3 should display.

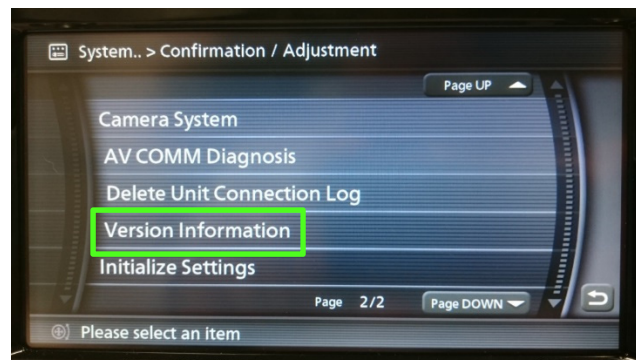
Figure 6

- If the SYS Software Version is **NOT 80836034 or higher**, turn the ignition OFF and continue to step 7 on page 4.
- If the SYS Software Version is **80836034 or higher**, this bulletin does not apply. Go to ASIST for further diagnostic and repair information.
