Service Bulletin

Bulletin No.: 19-NA-279

Subject: Radio Software Version V807 Over-the-Air Update

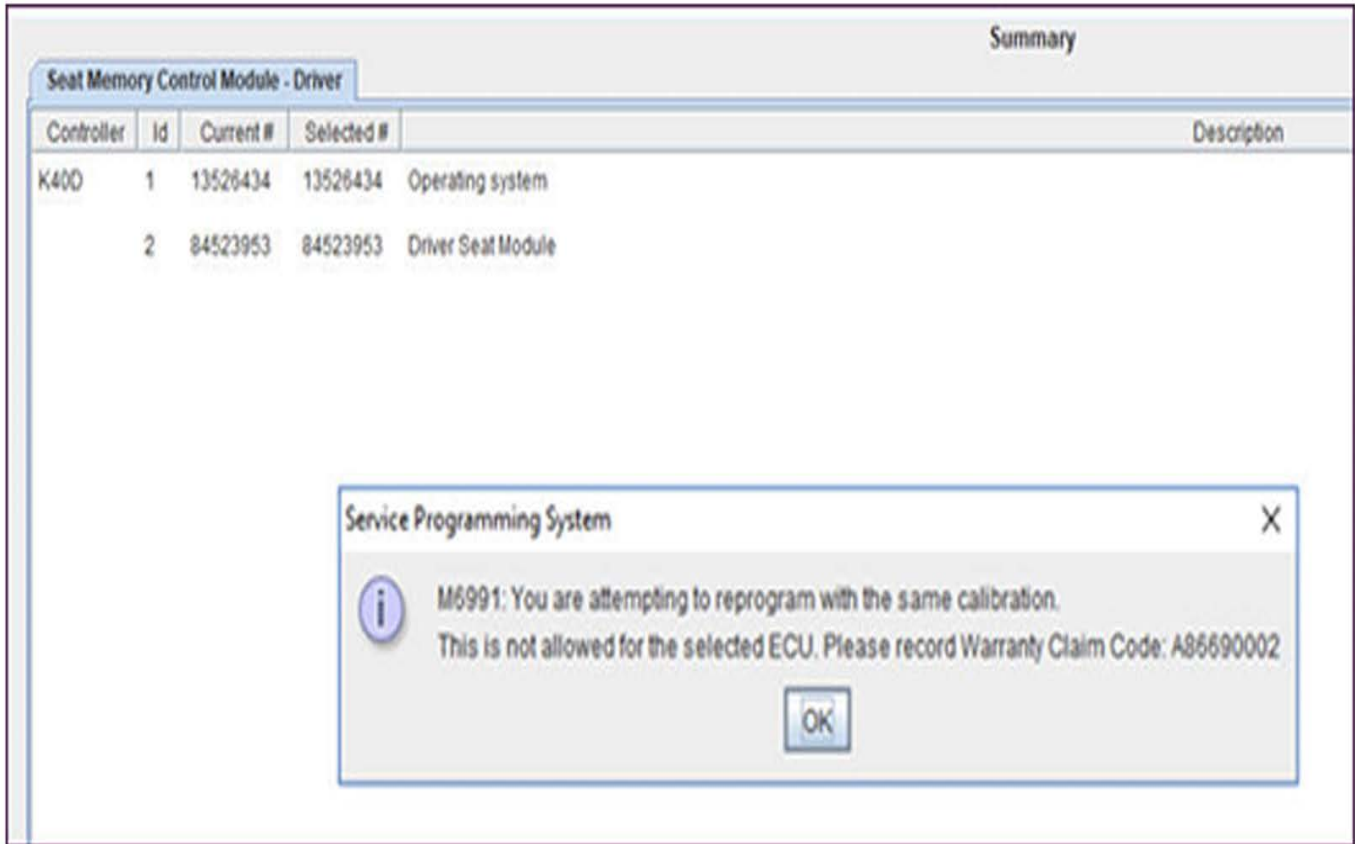
Note: If the Same Calibration/Software Warning is noted on the SPS Summary screen, record the warranty claim code (WCC) and select OK and follow screen instructions. After a successful programming event, the WCC is located in the Service Programming System dialogue box of the SPS Summary screen. No further action is required. Refer to the Warranty section of the bulletin.

1. Start SPS, select Radio – USB File Transfer and follow the on-screen instructions.
