## SERVICE BULLETIN

**APPLICABILITY:** 2017-18MY Impreza  
 2018MY Crosstrek  
 2018MY Legacy and Outback  
 2018MY BRZ\*

**NUMBER:** 15-211-17R  
**DATE:** 06/13/17  
**REVISED:** 02/19/20

**SUBJECT:** Reprogramming File Availability for Additional Optimization of Harman Gen 3 Audio and Navigation Head Units

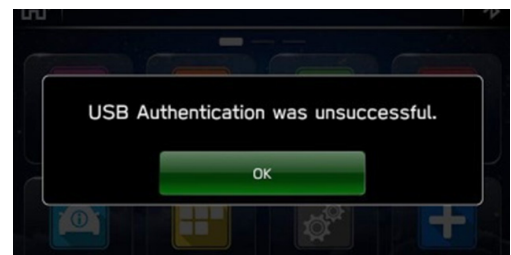
**CAUTION: NEVER** attempt to install this software on any 2019 MY vehicles as they are equipped with Gen 3.1 Audio/Navigation systems. This update is **ONLY** for models equipped with Gen 3.0 Audio/Navigation systems. Should an attempt be made to install any of these files into a Gen 3.1 head unit, the authentication error screen to the right will be displayed.

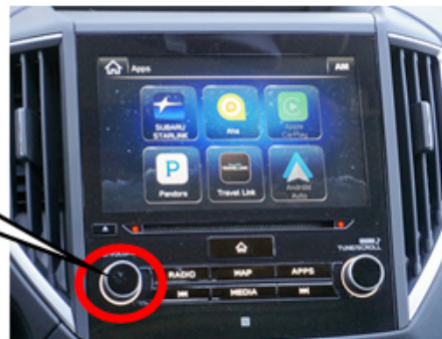
- The Mute function of the Power / Volume knob (a brief press and release of the Power / Volume knob to mute audio output) is unchanged.
- A “system reboot” function is initiated by pressing and holding the Power / Volume button for 10 seconds. This feature was included as part of the previous (11/2017) software update.
