Title: J1939 Data Link Troubleshooting

Applies To: All Models with 250k Baud Data Link (Black 9-Pin Diagnostic Connector); Overview information for 500k Baud Data Link

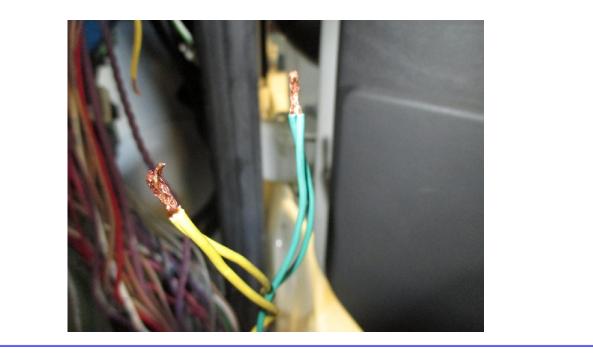
Harness removed from truck for identification

• 6/9/2014 - Recent information from the field has shown a potential failure location

• A poor connection on the splice the ties the ABS module into the Back-bone of the data link was found on multiple units

• If you have these faults and the vehicle build date is near August 2013 or Newer you will need to troubleshoot this splice in the data link if no obvious failures are found

• Cab temperature was affecting the data link behavior in one of the vehicles found to have this issue

• Inspecting the splice is destructive, you will need to remove the splice section use a closed barrel butt connector to crimp, solder and heat shrink the splice location. Use proper wire repair techniques as outlined in <u>IK0800269 - Proper Wire Repair</u>
