**SERVICE PROGRAM BULLETIN**

**APPLICABILITY:** 2015-2018MY Forester 2.0L Turbo  
2016-2018MY WRX 2.0L Turbo

**NUMBER:** WUK-96R

**SUBJECT:** DIT Exhaust Pipe Front (EPF) Nut Torque

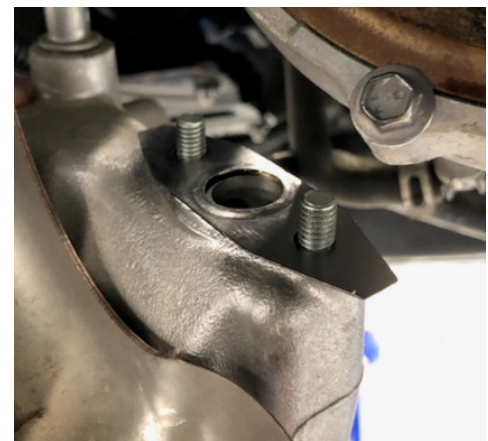
- Are any of the 6 EPF nuts shown in the figure below missing?
- Is there any trace of exhaust gas leakage (soot deposits) around the EPF mounting flanges at the cylinder heads? **IMPORTANT:** Always check for exhaust gas leakage even if all the EPF nuts are in place.

**Step 1:** Remove the front under cover and guard. Inspect the following two areas carefully:
