Field campaign

Topic	Bentayga - Control Unit for Fuel Pump (SC 20/05)
Market area	China 796 VW Import Comp. Ltd (Vico), Beijing (6796),United Kingdom E01 Bentley UK (6E01),United States E05 Bentley USA and rest America (6E05)
Brand	Bentley
Transaction No.	2058764/1
Campaign number	EB47
Note	
Type	Field Campaign
US code

Bentayga

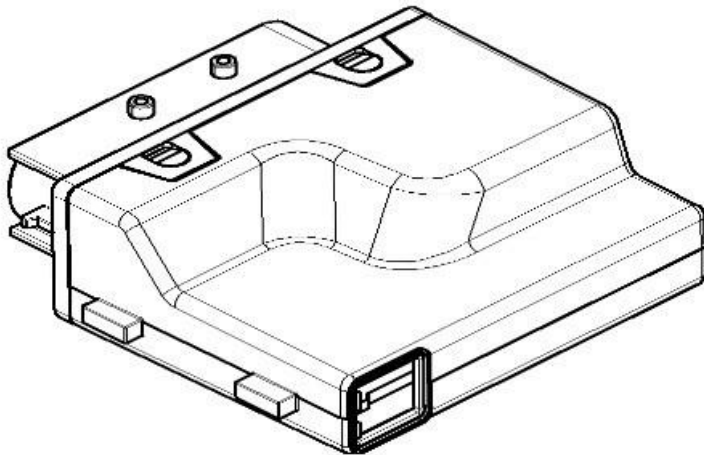
Fuel pump control unit 4M0 906 093K has been superseded by fuel pump control unit 4M0 906 093N, however, this change is not currently applicable to Bentley. A small quantity of "N" level control units were mistakenly issued as spare parts and have subsequently been fitted to Customer vehicles.

On vehicles with the "N" level part installed the Customer may complain of noise from the rear seat area, it is possible that fuel pumps may become noisy during operation. At present no other symptoms or faults are expected.

Correct level fuel pump control unit(s) should be installed – 4M0 906 093K.
