GROUP
Product Improvement

NUMBER
PI1803Y/Z (Rev 1, 04/09/2020)

PRODUCT IMPROVEMENT CAMPAIGN

**SUBJECT: ENGINE REPLACEMENT INSTRUCTIONS
FOR DTC P1326 (PI1803Y/Z)**

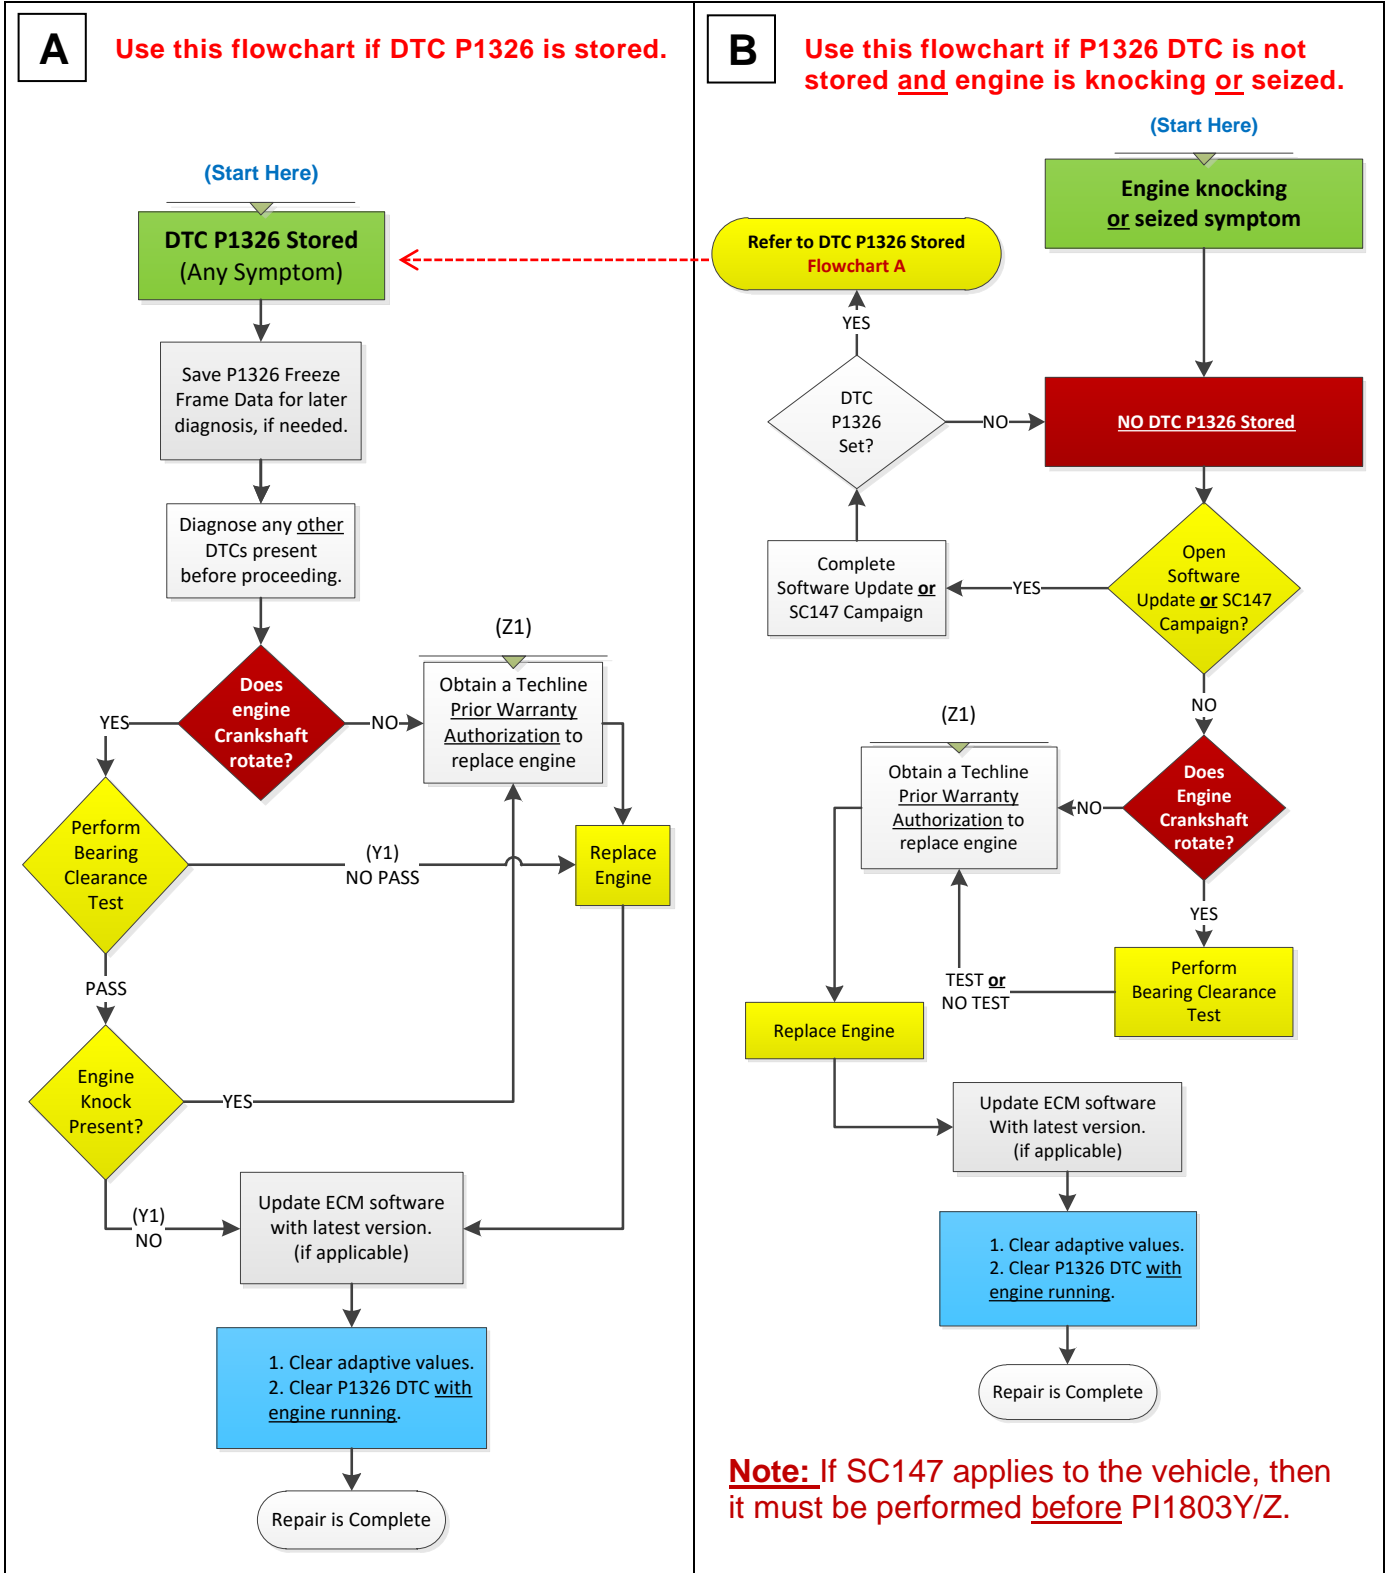
Choose the applicable flowchart based on the initial inspection:

- **Scenario 1** – Vehicle is in with DTC P1326 stored (A).
- **Scenario 2** – Vehicles is in with no DTC P1326 stored but engine is knocking or seized (B).
- **Scenario 3** – Vehicle is in with DTC P1326 stored and also engine is making noise or seized (A).

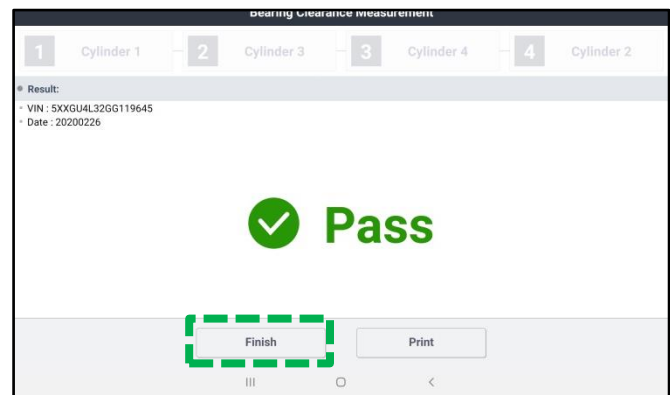
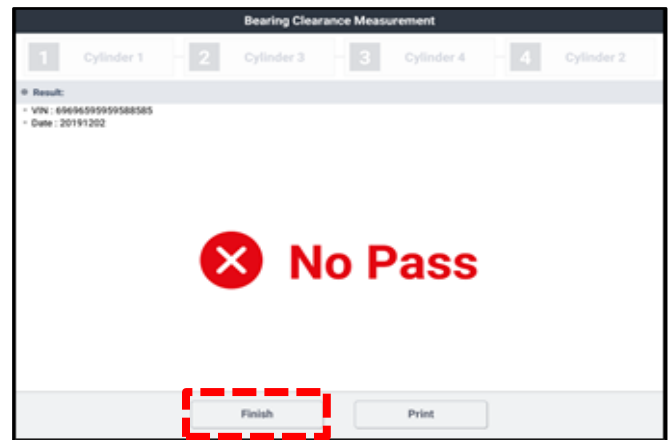
28. If the test result displays **“PASS”**, capture the screen image/screenshot for record keeping.

If the test result displays **“NO PASS”**, capture the screen image/screenshot for record keeping. Then proceed to replace the engine assembly per the instructions.

- Proceed to **page 11** to replace the engine assembly as outlined in this bulletin

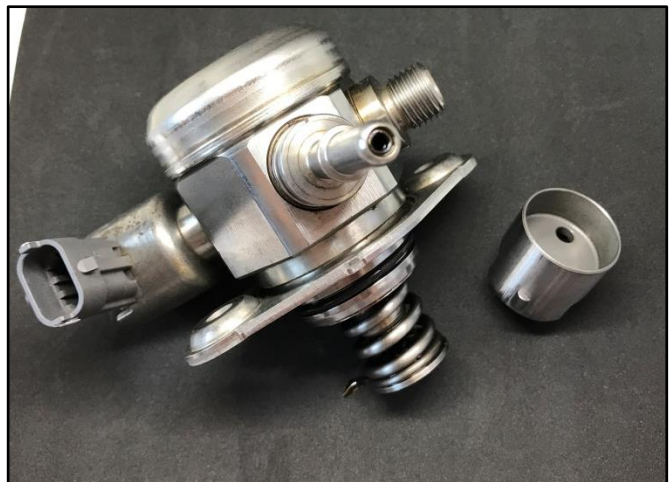
High Pressure Pump & Roller Tappet:

- Refer to [TSB ENG083](#) for special attention and handling procedures of GDI-specific components.
- When installing the high pressure pump and roller tappet onto the new engine, apply engine oil to the roller tappet, and O-rings of the high pressure pump.

Tightening torques of pump bolts:
9.4 – 10.9 lb.ft (12.8 – 14.7 N.m,
1.3 – 1.5 kgf.m)

Tightening torques of pipe flare nut:
19.5 – 23.9 lb.ft (26.5 – 32.4 N.m,
2.7 – 3.3 kgf.m)

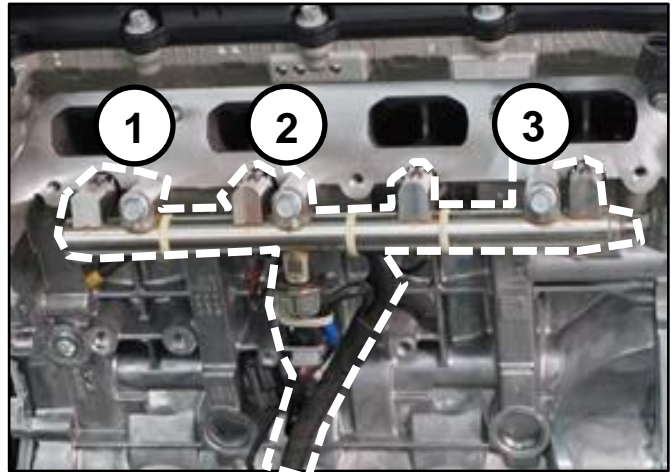
- Refer to [TSB ENG083](#) for special attention and handling procedures of GDI-specific components.
- Prior to installing the delivery pipe, be sure to replace all of the injector O-rings and injector retainers.
- Prior to installing the delivery pipe, apply engine oil to the injector O-rings.
- When installing the delivery pipe, use caution not to damage the tip of the injector.
- Be sure to replace the delivery pipe retaining bolts and torque them in the sequence shown.

Tightening torque of bolts:

**13.7 – 17.4 lb.ft (18.6 – 23.5 N.m,
1.9 – 2.4 kgf.m)**

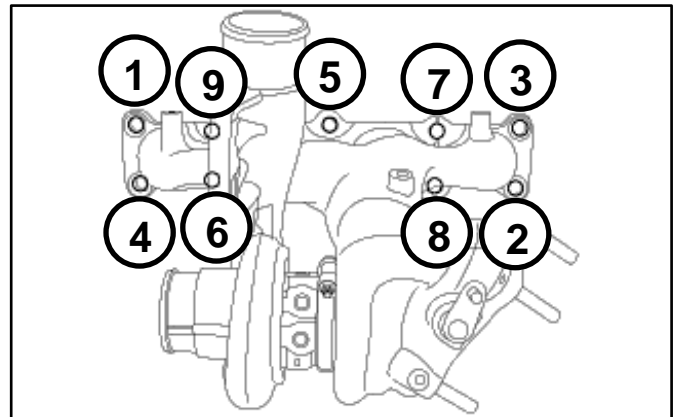
- Torque exhaust manifold nuts in the sequence shown.

Tightening torque of nuts:
 36.2 – 39.7 lb.ft (49.0 – 53.9 N.m,
 5.0 – 5.5 kgf.m)

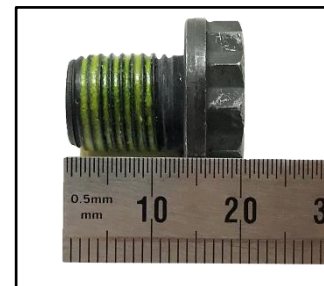
Drive Plate Bolt (A/T)

- Replace all seven (7) drive plate (AT) bolts.

Tightening torque of nuts:

**86.8 – 93.9 lb.ft (117.7 – 125.5 N.m,
12.0 – 13.0 kgf.m)**
