**NUMBER:** 23-001-20 REV. B

Leather Instrument Panel (IP) Cover Delaminating - X81 Warranty Extension

2011 - 2014 (WK) Jeep Grand Cherokee

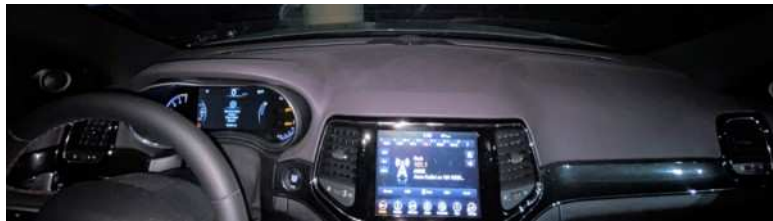
**Fig. 2**  
Entire Width Of IP Cover For Claim Submittal

- To obtain pre-approval for this Repair Procedure, submit digital photos of the VIN, IP cover at the A-pillars, IP cover damage (Fig. 1) and an entire width of the IP cover (Fig. 2) .
- Submit all digital photos to the following email address: [x81digitalimagingapproval@fcagroup.com](mailto:x81digitalimagingapproval@fcagroup.com)
