Service Bulletin

Bulletin No.: 20-NA-071

Subject: Service Engine Soon Lamp Illuminated and/or Service Power Brake Assist Message Displayed, with DTCs P0557 or P0558 Stored

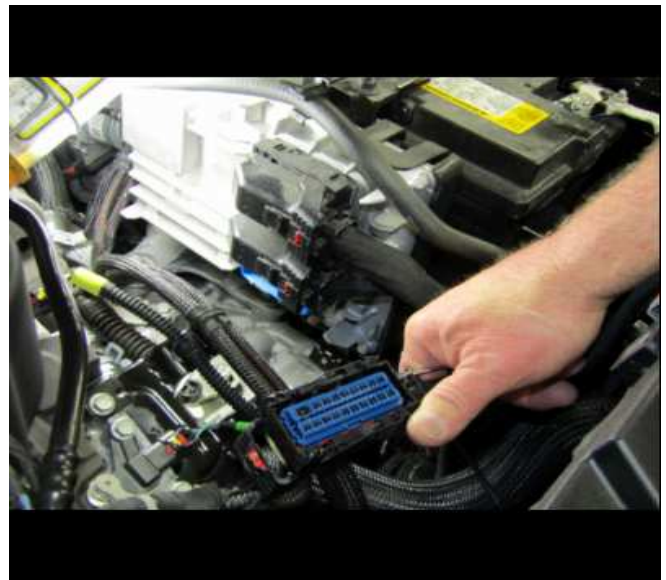
5549626

Note: The LFY harness routing is shown in the top graphic, the LGX routing is shown in the bottom math file. The routing for LCV is similar to the routing of the LGX.

10. Start routing the new harness alongside the engine harness.
