# SERVICE BULLETIN

Classification: EL20-008a	Reference: NTB20-016a	Date: May 18, 2020
------------------------------	--------------------------	-----------------------

## RADIO INTERMITTENTLY REBOOTS DURING AUDIO PLAYBACK VIA BLUETOOTH CONNECTED IPHONE

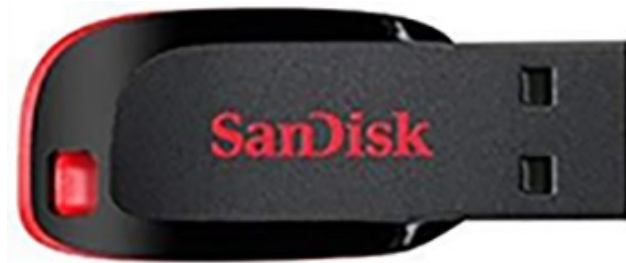
Figure 1

- One of special tool USB drive J-52727 has been shipped to each dealer (see Figure 1).
- Do not use any other USB drive to perform the procedure in this bulletin.
- Additional USB drives may be purchased from Tech•Mate: [nissantechmate.com](http://nissantechmate.com) or 1-800-662-2001.

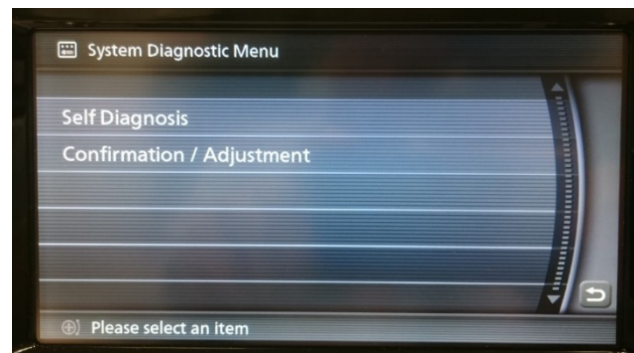
**NOTE:** The screen in Figure 2 should display.

1. Turn the ignition ON.
2. Turn the audio system OFF.
3. Access the System Diagnostic Menu as follows:
  - a. Press and hold the **MENU** button.
  - b. Turn the **VOLUME** knob 40 or more clicks in either direction.

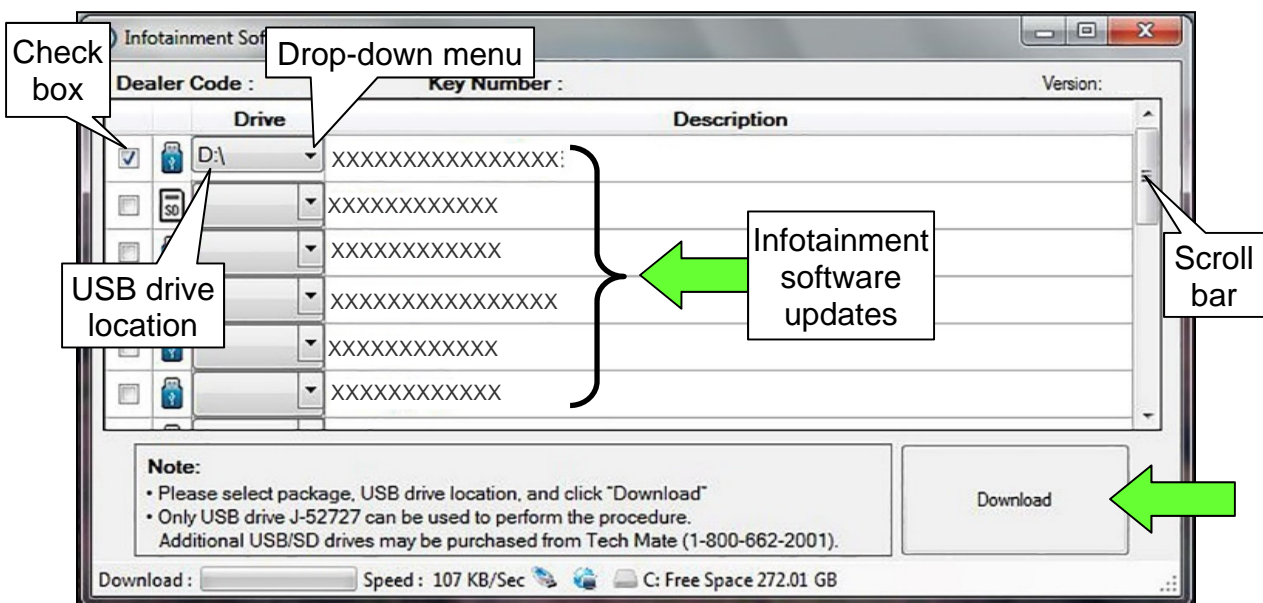
**HINT:** The **Description** section in Figure 8 may be different than on your C-III plus screen.

- Select the check box next to the correct update software package (Figure 8).
  - Locate update file #1 (LD001) and update file #2 (see **Table A** above).
  - Only one (1) update will be loaded at a time, starting with update #1 (LD001).

**NOTICE** To avoid damage to the vehicle, ensure the correct update software package is selected. Failure to select the correct update software package may result in needing to replace the AV control unit.

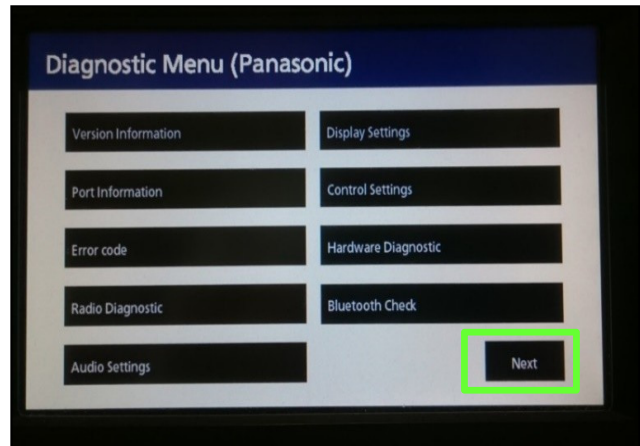
**HINT:** A screen similar to the one in Figure 15 will appear.

- a. Press and hold the **Menu** button.
- b. Press and hold the **Audio** button.
- c. Press the **Seek right** button three (3) times.

- d. Select the **Next** button at the bottom right side of the screen.
