Service Action

Code: 97DZ

Subject	Transmission Wiring Harness																												
Release Date	June 09, 2020																												
Affected Vehicles

Subject: Service Action 97DZ – Transmission Wiring Harness

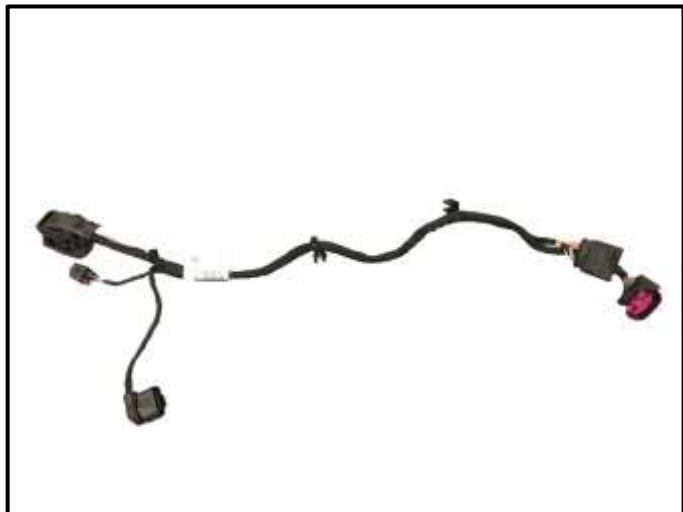
Repair Overview

What is the issue? The transmission wiring harness may not be properly secured, causing it to rub and possibly become damaged.

- Modify transmission wiring harness.
- Repair wiring if necessary.
