# Product Upgrade Bulletin 200515REV

**PRODUCT(S) AFFECTED:**  
American Coach  
Dream and Revolution

**SUBJECT:**  
Inspection /  
Correction  
of Aqua-Hot  
Exhaust Pipe &  
Chrome Tip

**ISSUE DATE:**  
June 2020

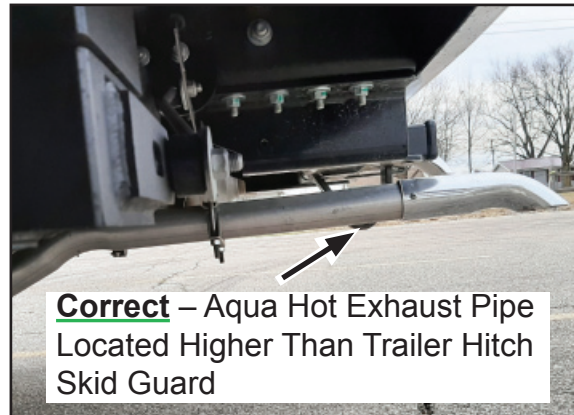
Figure 3

On motorhomes affected by this Product Upgrade, an older revision of the rear pipe section of the Aqua-Hot exhaust may have been installed during production, resulting in a configuration that will make the Aqua-Hot exhaust pipe exit the rear of the coach, below the trailer hitch skid guard. This could cause the exhaust pipe's chrome tip to become damaged from scraping if the vehicle is driven on an incline.

- a) If the Aqua-Hot exhaust is located higher than the skid guard, the installation is correct and no further work is required. Attach photos to a draft claim in A.D.N. and submit as “Inspected/Not Defective” using the repair code on Page 5.
- b) If the Aqua-Hot exhaust is located lower than the skid guard, it will need to be replaced. Continue to the REPAIR PROCEDURE beginning at Step 5 on Page 3.
