# Ferrari North America

## Technical Information

Date: June 2020  
 Bulletin #: 2668  
 Campaign #:   
 Supersedes: 2344  
 Section: 3

Subject: Replacing CCP pressure sensors

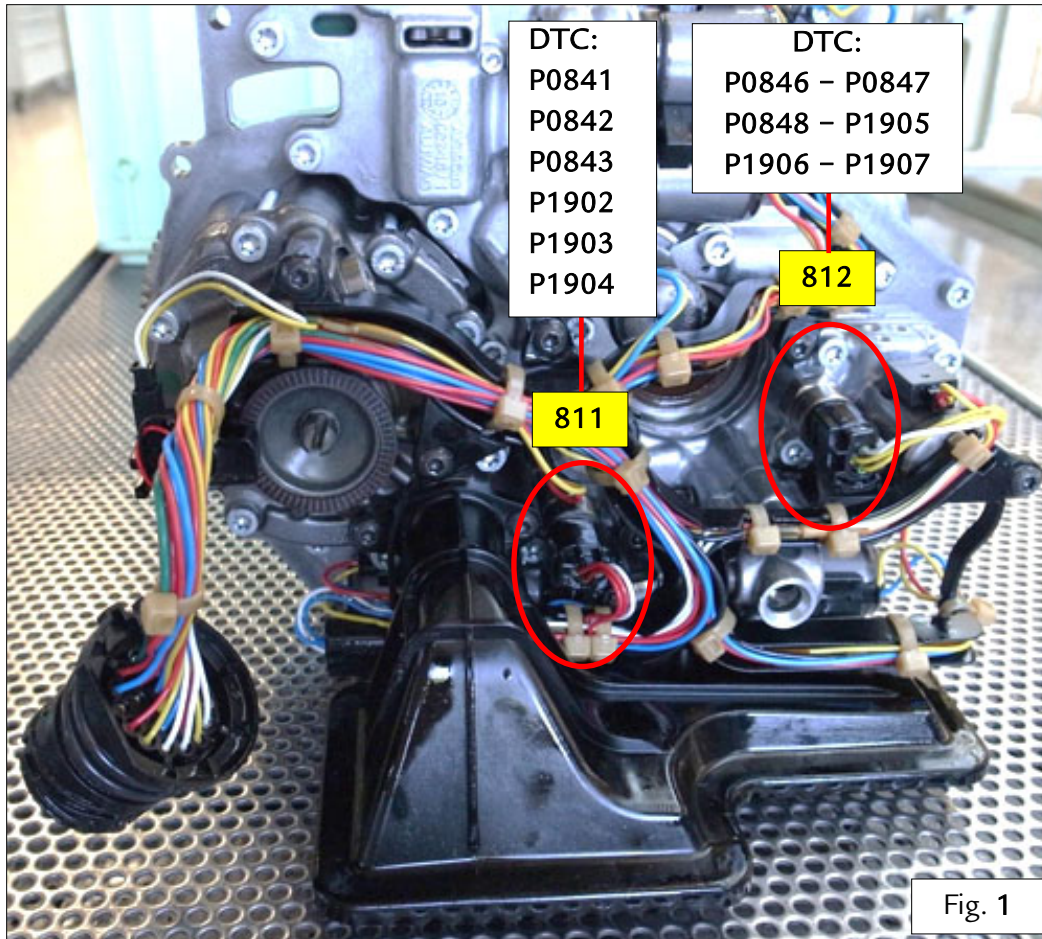
- Replacing “811” clutch pressure sensor C1 (Fig. 1)
- Replacing “812” clutch pressure sensor C2 (Fig. 1)
- Replacing “880” system pressure sensor (Fig. 2)

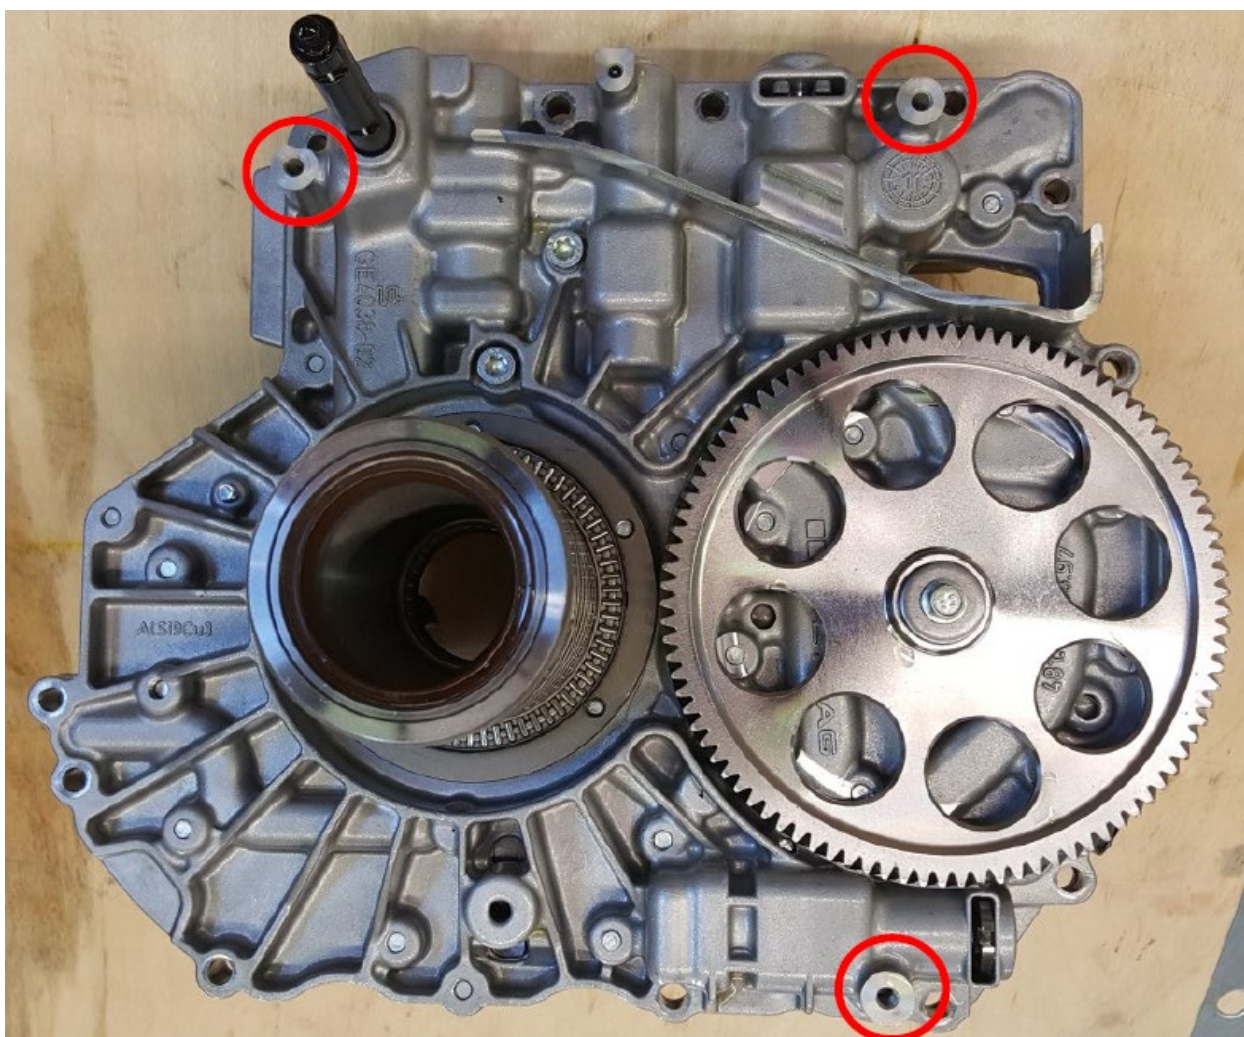
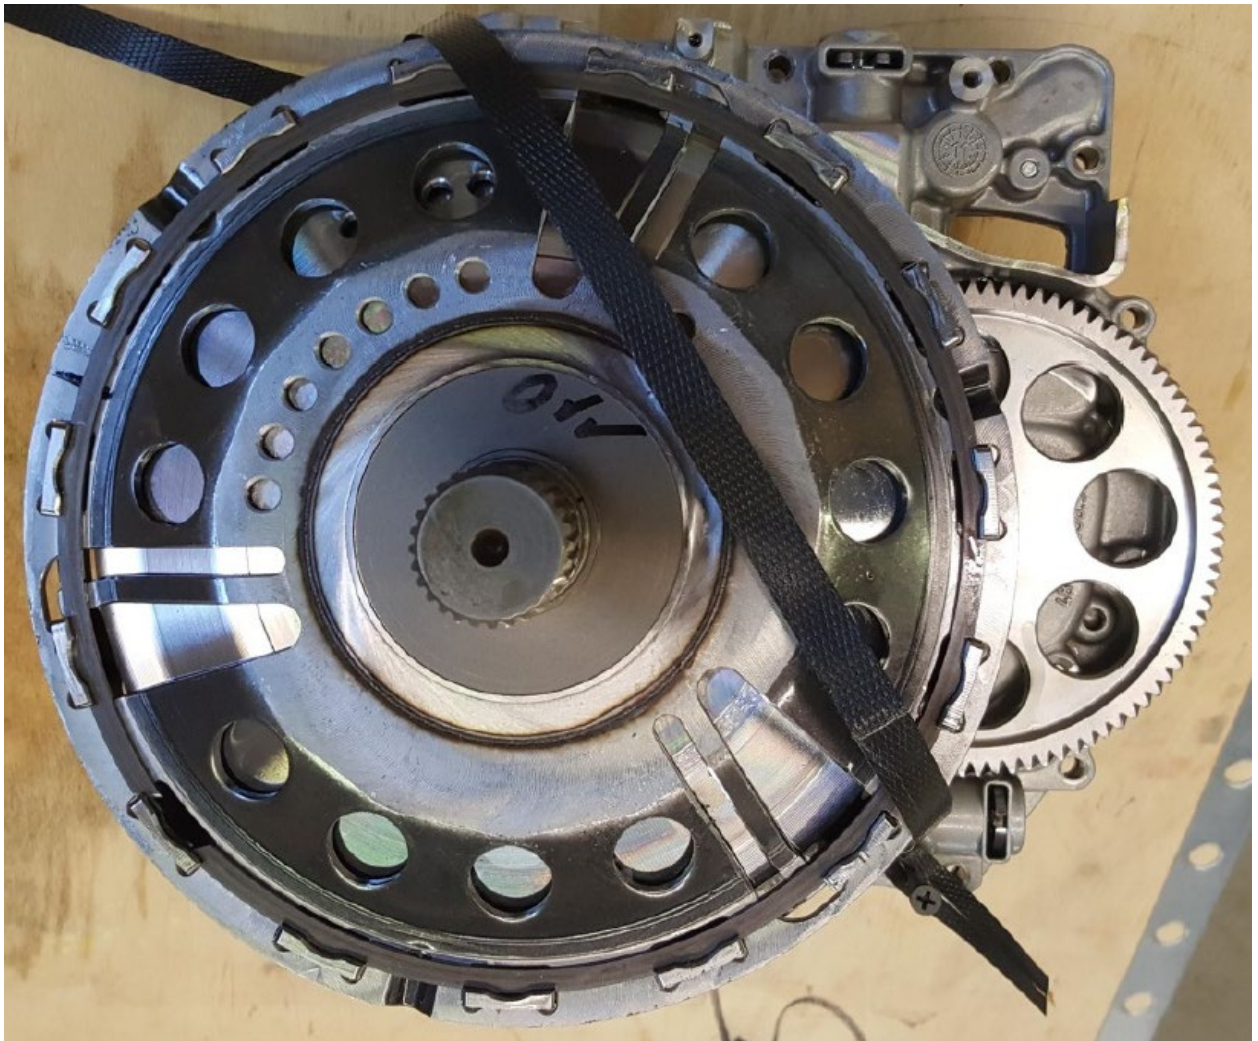
strap / retainer

Before mounting the CCP to the relative carrier, the clutch basket must be fastened to the CCP to avoid damaging the seals. You can zip tie the clutch basket to the oil pump sprocket or fasten the clutch basket onto the CCP with a strap like shown below
