<b>Subject:</b> <b>"IN-VEHICLE NETWORK MALFUNCTION" INSTRUMENT CLUSTER WARNING MESSAGE</b>	<b>Service Alert No.:</b> SA-029/20
	<b>Last Issued:</b> 06/23/2020

2019-2020 Mazda3  
2020 CX-30

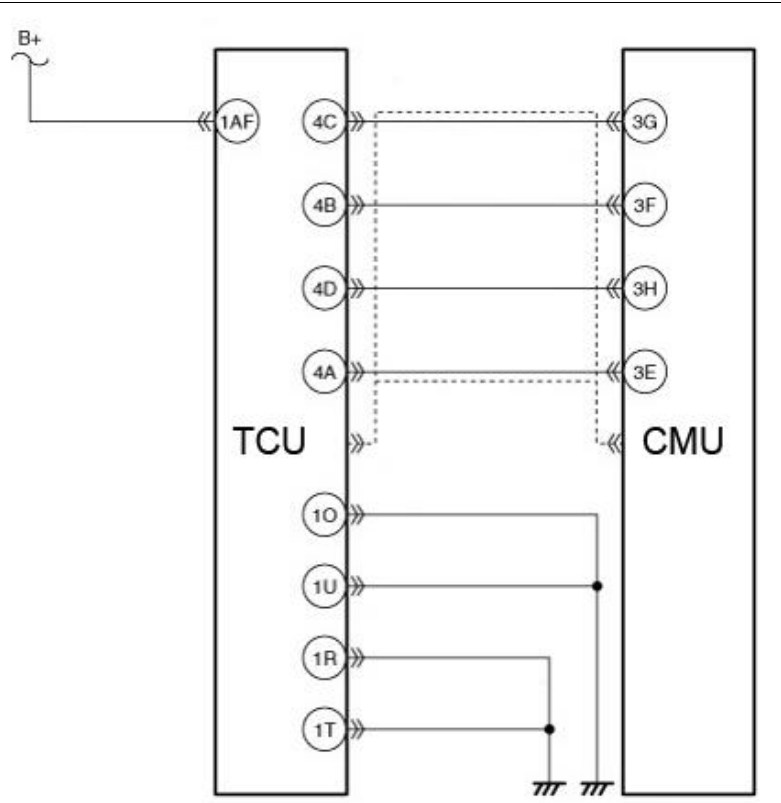
<p>U0156:00</p>	<p>1. Refer to the instructions on MGSS.</p> <ol style="list-style-type: none"> <li>Mazda3 DTC U0156:00 [BODY CONTROL MODULE (BCM)]</li> <li>CX-30 DTC U0156:00 [BODY CONTROL MODULE (BCM)]</li> </ol>
<p>U0198:00</p>	<p>1. Check USB cable connections between TCU and CMU.</p>
