GLOBAL SAFETY FIELD INVESTIGATIONS  
DCS5422  
URGENT - DISTRIBUTE IMMEDIATELY

Subject: A202302140-01 - Service Update  
Engine Oil Pressure Sensor Performance Error  
Revised Part, Warranty and Service Procedure sections

Models: 2020 Buick Encore GX  
2021 Chevrolet Trailblazer  
Equipped with 1.2L Turbo Engine (RPO LIH)

## A202302140 Engine Oil Pressure Sensor Performance Error

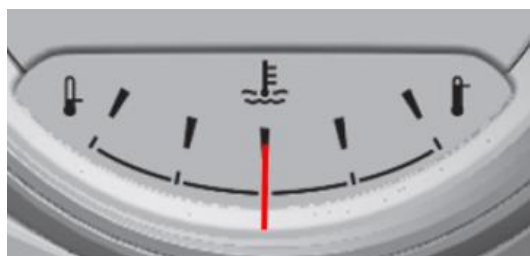
5584378

3. Start and run engine for minimum 15 minutes until the coolant temperature gauge needle is centered in the gauge.

4. Raise the engine speed to 2,000 rpm for 30 seconds.
5. Rev up the engine rpm to 4,000 rpm limit and hold for 15 seconds.
6. Release the acceleration pedal to go down rpm to idle and wait for 15 seconds.
