TSB Number:	TSB 01-004-20B
Product:	Thule® Regal Awning
Date:	June 19, 2020

NOTE: This bulletin supersedes TSB 01-004-20 dated April 17, 2020, which should be removed from your files.

This document outlines the inspection (and correction) of Thule Regal Awnings to determine if there is too much gap between the roll tube and end plates, which could cause the fabric to extend over the edge or the roll tube could shift along the axle plane.

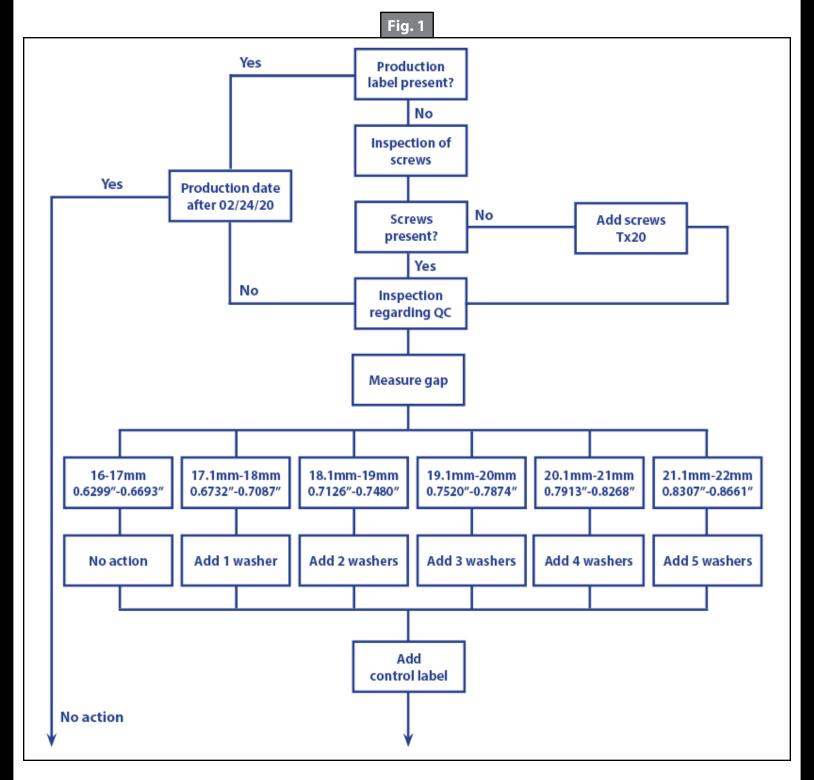
Check the following steps on the flow chart (Fig. 1) to determine if the awning needs to be modified.

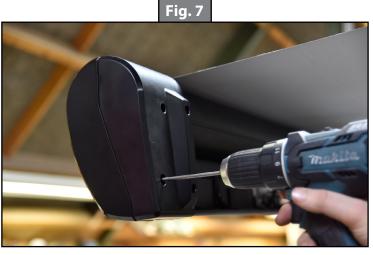
- 2. Remove the 15mm torx fastener securing the front end cap (Fig. 7) with appropriate bit.
- **3.** Pop off the front end cap (Fig. 8A) with a flat head screwdriver or pry bar.

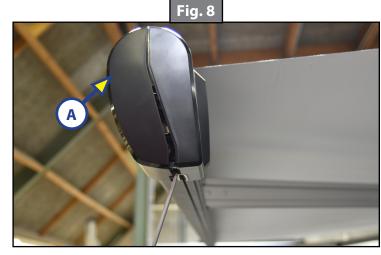
- **4.** Set front end cap (Fig. 8A) aside for re-installation.
- **5.** Repeat steps 1 through 4 for the other end cap. Retain hardware for re-installation.
- **6.** Using a micrometer measure the gap between the awning roll tube and end plates on both the right and left sides (Fig. 10).
- **7.** Add the two measurements and see Tolerance Inspection Table on page 6 for measurement specifics.
