CAMPAIGN BULLETIN

Fuel Filler Door Bumper Dealer Inventory

Reference: PM948

PM948 – 2020 SENTRA FUEL FILLER DOOR BUMPER

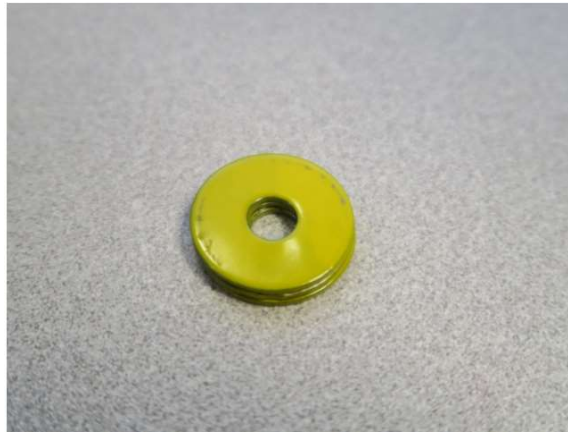
Figure 1

This procedure requires the use of a Special Trim Guide.
The Special Trim Guide has been provided to all Dealer Service Managers.
