# Technical Service Bulletin

## 39 Four-wheel drive malfunction message, DTC C05ED00 is stored in the all-wheel drive control module

39 20 35 2051558/4 August 21, 2020. Supersedes Technical Service Bulletin Group 39 number 20-32 dated June 17, 2020 for reasons listed below.

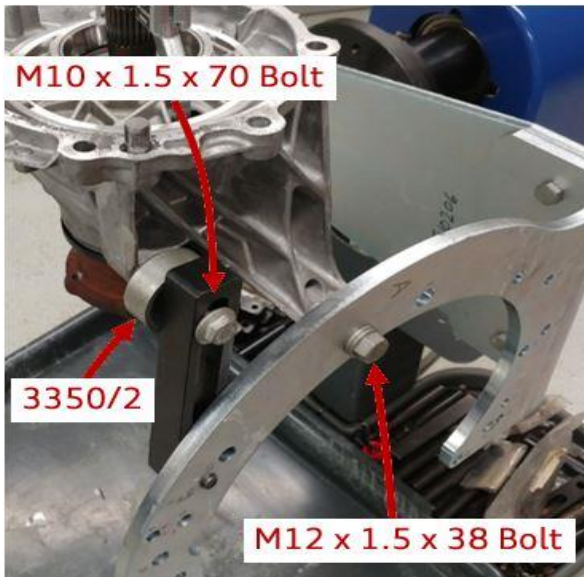
**Figure 4.** Mounting detail.

- Mount the side carrier as shown below (Figure 3) to the VAS6095 using T40206, T40206/1A, one long slotted arm from the VAS6095, 3350/2 (Figure 4 and Figure 5), three M10 flat washers 2mm thick each (Figure 5), one M10 x 1.5 x70 bolt (Figure 4 and Figure 5), and one M12 x 1.5 x 38 bolt (Figure 4).

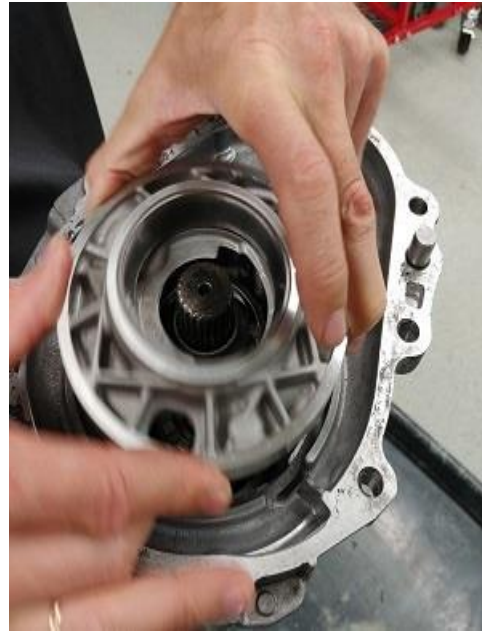
**Figure 10.** Gear carrier removal.

7. Remove the gear carrier (Figure 9, position 1 and Figure 10). During this step, guide the shift fork out of the clutch module (engagement collar), then remove the shim (Figure 9, position 2).

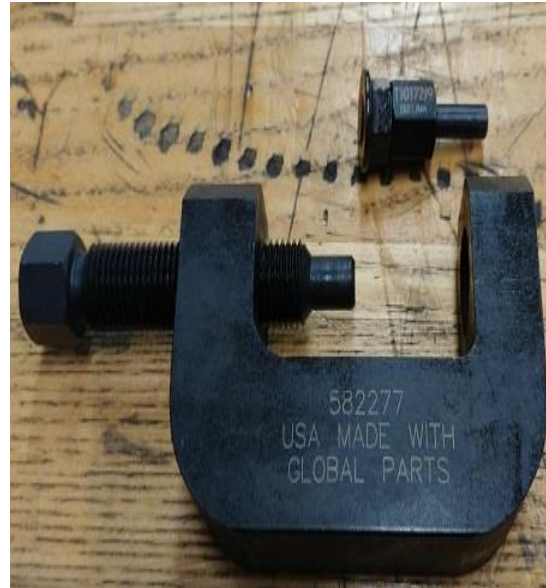
**Figure 16.** Stud remover 582277.

As a workable option, the minimum required tool 582277 Stud Remover can be used in place of a vise with T10172/9 with an M8 flange nut threaded on the T10172/9 (Figure 16).

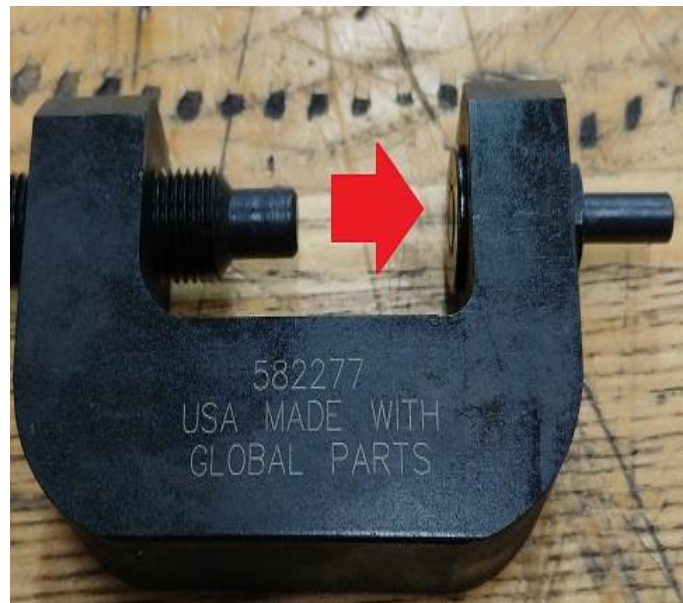
**Figure 17.** T10172/9 installed in 582277.

12b Insert the T10172/9 with the M8 flange nut as shown and the collared nut provides a solid surface to press the pin against (Figure 17).

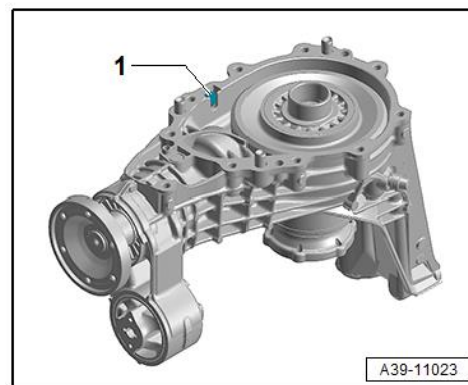
**Figure 22.** Magnet location.

15. Remove the magnet (Figure 22, position 1), clean it, and re-insert.

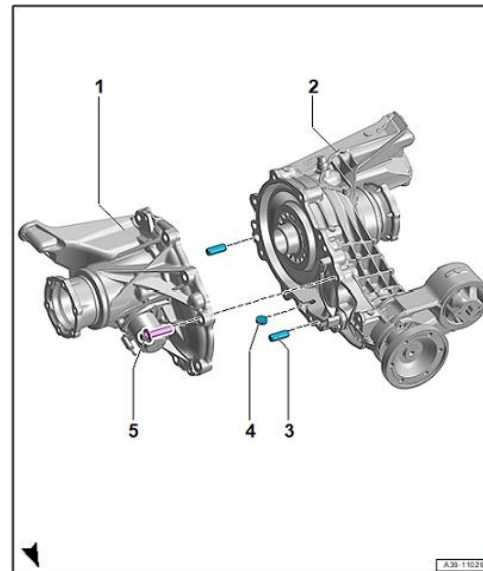
**Figure 24.** Case halves.

17. Reassemble the case halves.
