**SERVICE BULLETIN**

**APPLICABILITY:** 2017-18MY Impreza  
 2018MY Crosstrek  
 2018MY Legacy and Outback  
 2018MY BRZ\*

**NUMBER:** 15-211-17R  
**DATE:** 06/13/17  
**REVISED:** 08/31/20

**SUBJECT:** Reprogramming File Availability for Additional Optimization of Harman Gen 3 Audio and Navigation Head Units

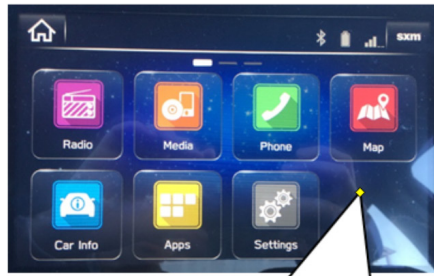
- On 2018MY Legacy / Outback models with Navigation (High) head units, the update corrects a condition where the head unit remains powered even after the ignition is OFF and the driver door is opened.
- Update for a condition where the SXM presets become lost and only “Initializing” appears as shown below.
- Update for condition where only the star field background is displayed (without icons) after the HOME button is pressed.

Normal HOME screen with icons
